## U.S. PUBLIC LAND SURVEY MONUMENT RECORD

Quarter Corner common to Sections 27 and 34 Township 31 North, Range 7 East of the 4th P.M. Town of Pine River, Lincoln County, Wisconsin

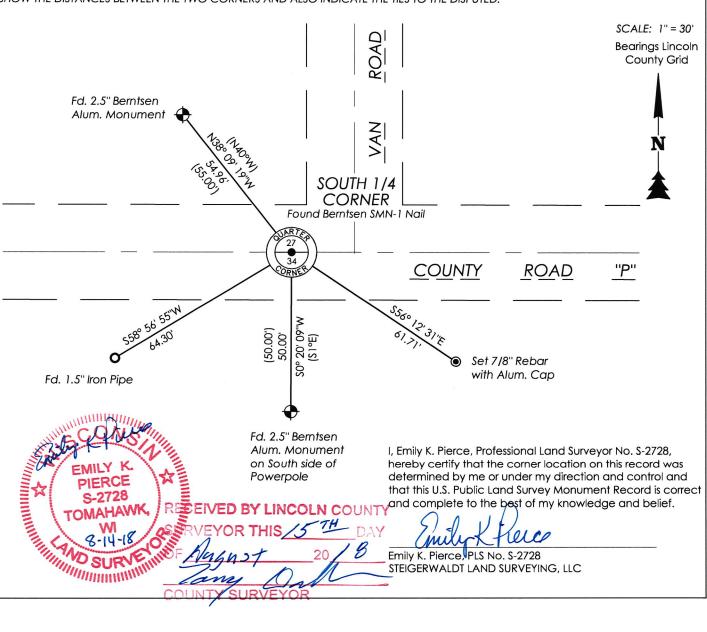
PLAN VIEW OF CORNER WITH TIES TO AT LEAST 4 WITNESS MONUMENTS. IF IN DISAGREEMENT WITH PREVIOUSLY ESTABLISHED CORNER, SHOW THE DISTANCES BETWEEN THE TWO CORNERS AND ALSO INDICATE THE TIES TO THE DISPUTED.

FOUND DETERIORATED BERNTSEN MONUMENT

8/02/2018 I visited corner location and found a Berntsen SMN-1 nail in the centerline of County Road "P", approximately 20 feet west of the centerline of Van Road. I found 2 Berntsen Aluminum monuments at the tie locations to the NW and to the S. I also found the remaining magnet and an aluminum powder at the location of the previous tie to the SE as shown on the 1974 tiesheet. Accepted the two existing Berntsen monuments as being the same ties that were identified as brass caps in concrete. Accepted Berntsen SMN-1 nail as being in the correct corner location as it fit the remaining ties well. I also found a 1.5" iron pipe to the SW and used it as a tie to the corner. Set a 7/8" rebar with cap to the SE to replace tie that only remnants remained.
