U.S. PUBLIC LAND SURVEY MONUMENT RECORD

SOUTHEAST CORNER, SECTION 7
TOWNSHIP 35 NORTH
RANGE 6 EAST
TOWN OF BRADLEY
LINCOLN COUNTY
WISCONSIN

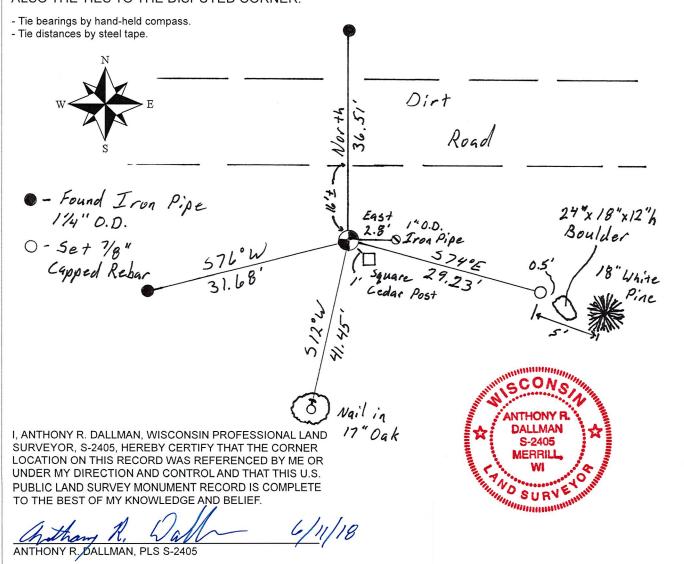
06/04/2018, I, Anthony R. Dallman, PLS-2405, found the Berntsen Monument, flush, Cedar post and all four reference ties as noted on Blixt tie sheet, the 12" Maple is dead and mostly rotted. I accepted this location, remeasured remaining reference ties and set a new reference tie to further perpetuate the corner location, as shown in the sketch below.
