U.S. PUBLIC LAND SURVEY MONUMENT RECORD

Quarter Section Corner common to Sections 9 and 10
Township 35 North, Range 5 East of the 4th P.M.
Town of Somo, Lincoln County, Wisconsin

U. S. PUBLIC LAND SURVEY MONUMENT RECORD

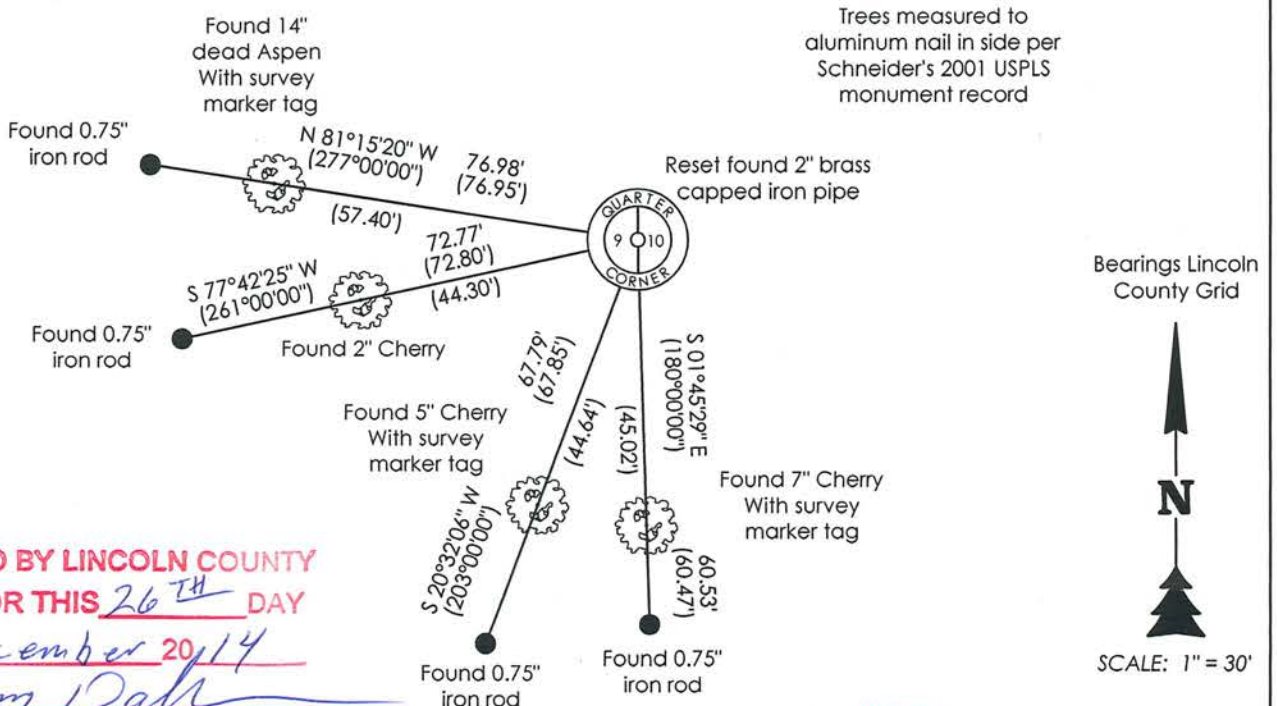
Dec. 2014 - Chad A. Besaw found a 2" x 48" brass capped iron pipe with a 12" piece of angle iron welded to the bottom lying flat. Lying next to said pipe was a white fiberglass T-post and a typical Burnett monument rusted in two as Schneider mentioned in his 2001 monument record. I reset the 2" pipe per Schneider's ties all of which were in good condition. While digging the hole for the monument I found a 12" section of wood post 4" in diameter that was rotted off at one end and wedged at the other. This corner is located in the SW corner of an open marsh previously flooded. I was unable to locate the 1961 Genisot map in the Lincoln County Land Information records. See Section Summary filed with this USPLS monument record. Witnessed as shown below:

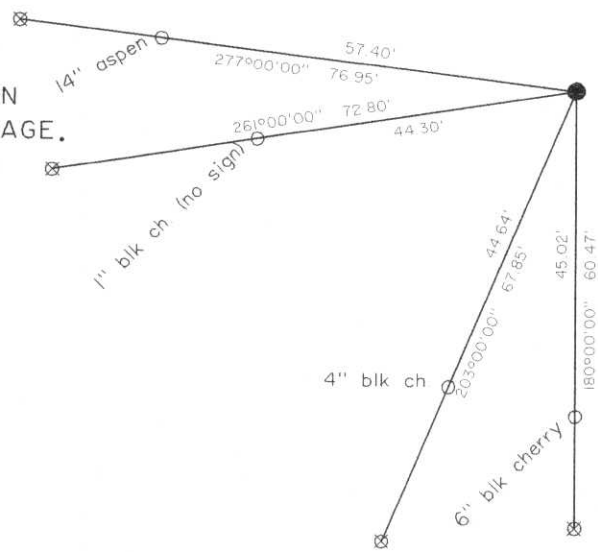
34. HERETOFORE UNDOCUMENTED LINCOLN CO. SURVEY MONUMENT. ACCORDING TO GENISOT
35. PRIVATE NOTES, A 1-1/2" CAPPED PIPE WAS FOUND.
36. PRESENT COR. MON. - PIPE, LINE 27. SET WHITE FIBERGLASS FENCEPOST 4" EAST.

37. PRESENT WITNESS MONUMENTS-
38. 3/4" X 30" SOLID ROUND IRON BARS,
39. DRIVEN FLUSH.
40. GENERAL AREA DESCRIPTION- BT'S ARE ON
41. SW EDGE OF OPEN MARSH BY BEAVER FLOWAGE.
