# U.S. PUBLIC LAND SURVEY MONUMENT RECORD

Section Corner common to Sections 2, 3, 10 and 11 Township 35 North, Range 5 East of the 4th P.M. Town of Somo, Lincoln County, Wisconsin

### CERTIFIED LAND CORNER RESTORATION

Index No. *E* - 17

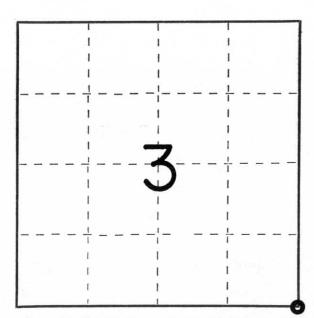
Dec. 2014 - Chad A. Besaw found Winat's Berntsen monument 4' north of CL Carpenter Rd. broken off and down 12" from road surface. I accepted the midpoint of the remaining section of the Berntsen monument as the corner location and will replace the broken monument with a new berntsen after the road thaws. See Section Summary filed with this USPLS monument record. Witnessed as shown below:

PLAN VIEW OF CORNER WITH TIES TO AT LEAST 4 WITNESS MONUMENTS. IF IN DISAGREEMENT WITH PREVIOUSLY ESTABLISHED CORNER, SHOW THE DISTANCES BETWEEN THE TWO CORNERS AND ALSO INDICATE THE TIES TO THE DISPUTED. 7/8" capped rebar 1' SW of 7/8" capped rebar 3.9' SE of 4" balsam Bearings Lincoln County Grid Found broken berntsen hwy monument (to be replaced in spring) CL Carpenter Rd. Fence Line 7/8" capped rebar 0.5" 3 East of wood fence post Drive RECEIVED BY LINCOLN COLWhite vinyl T-post set 0.5' South 7/8" capped rebar 1' NW of 5" double blazed aspen SURVEYOR THIS 26 ence SCALE: 1" = 30" SCONSIA Line I, Chad A. Besaw, Registered Land Surveyor No. S-3029, hereby certify that the corner location on this record was determined by me or MEKO. WI WI OR
