U.S. PUBLIC LAND SURVEY MONUMENT RECORD

(a) Corner location: Township 32 North

Range 7 East

Section 3

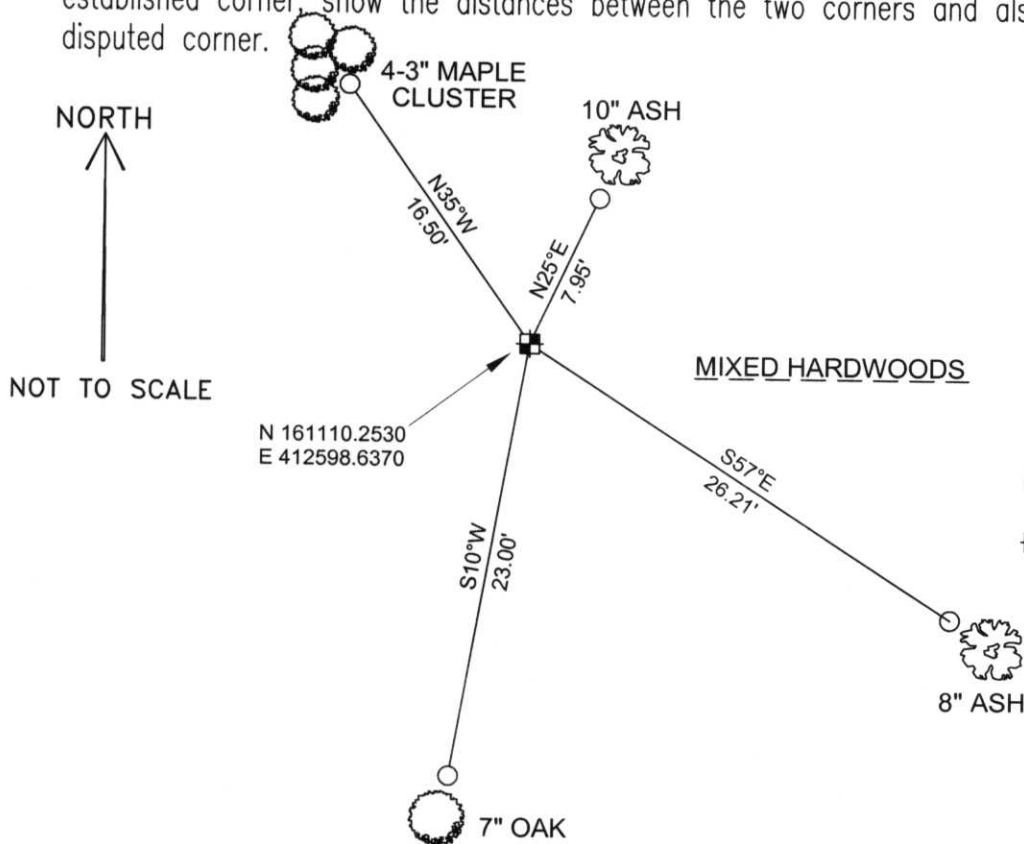
FOUND 6" X 6" GRANITE STONE SCRIBED AND ACCEPTED AS THE CORNER LOCATION.
SET TIES TO PERPETUATE CORNER LOCATION.

COORDINATES ARE REFERENCED TO THE LINCOLN COUNTY COORDINATE SYSTEM AS DEVELOPED BY THE WISCONSIN DEPARTMENT OF TRANSPORTATION AND WERE DETERMINED BY GPS OBSERVATIONS ON CONTROL POINTS AS SUPPLIED BY LINCOLN COUNTY.

BEARINGS ARE REFERENCED TO MAGNETIC NORTH.

- - SET 3/4" x 30" REBAR W/ ALUM CAP 1' FROM BEARING TREE
- ⊕ - WEST 1/4 CORNER FOUND 6" x 6" GRANITE STONE
