LINCOLN COUNTY U.S. PUBLIC LAND CORNER RESTORATION

i ile Q	uarter corner common to Sections 23 & 24, 1, 34 N., R. 5 EW.	10.10500.0000
		4340523 2000
Corner was: (check all that apply)		
	Restored through acceptance of an obliterated evidence location.	
	Restored through acceptance of a found perpetuated location.	
X	Determined to be lost and re-established through proportionate methods.	
	Show bearings and distances to PLSS corners used for proportioning, and show original distances).	
	Restored/re-covered/re-established in a location that differs from a previously established position.	
	(Show difference in plan view below).	
	Check here if addition information is shown on the reverse side of this form.	
Describe record evidence, recovered physical evidence, occupational evidence, testimonial		
evidence and all other evidence considered in the recovery/restoration of the corner

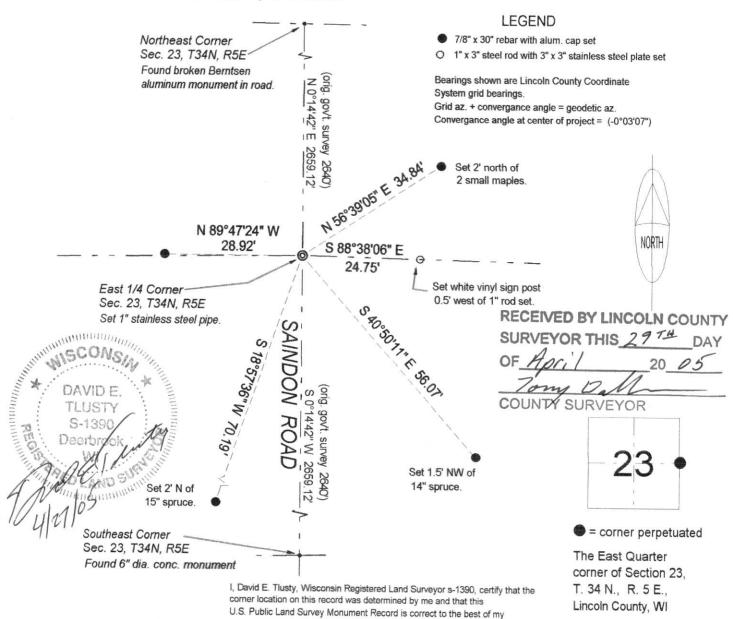
I re-established this corner by single proportionate measurement between the NE and SE corners of Section 23 as shown

below. Corner witnessed by adjoining landowner, David Seidler.

Describe the accessories used to perpetuate the corner. Include a plan view drawing and accessories found/set. Describe measuring point on bearing trees. Show any topographic features that would aid in future recovery of the corner.

For the corner, I set a 1" (ID) x 24" stainless steel pipe, with barbed points welded to the bottom and a 2 1/2"± brass washer attached to the top, which is 8" below the gravel road surface. The corner falls approx. 5 feet west of the center of the existing gravel roadway.
