I, David E. Tusty, Registered Land Surveyor, do hereby certify that, by the direction of David Seidler, owner, I have made a survey of the North Half of the Southwest Quarter of Section 24, Township 34 North, Range 5 East, Lincoln County, Wisconsin, as shown hereon. I further certify that this map is a true and correct representation of said survey and that this survey is correct to the best of my knowledge and belief.

David E. Tusty, RLS Deerbrook, Wisconsin 54424			
Survey for David Seidler, owner The North Half of the Southwest Quarter of Section 24, T. 34 N., R. 5 E., Lincoln County, WI			
SCALE:	DATE:	DRAWN BY:	MAP #:
1" = 150'	April 2005

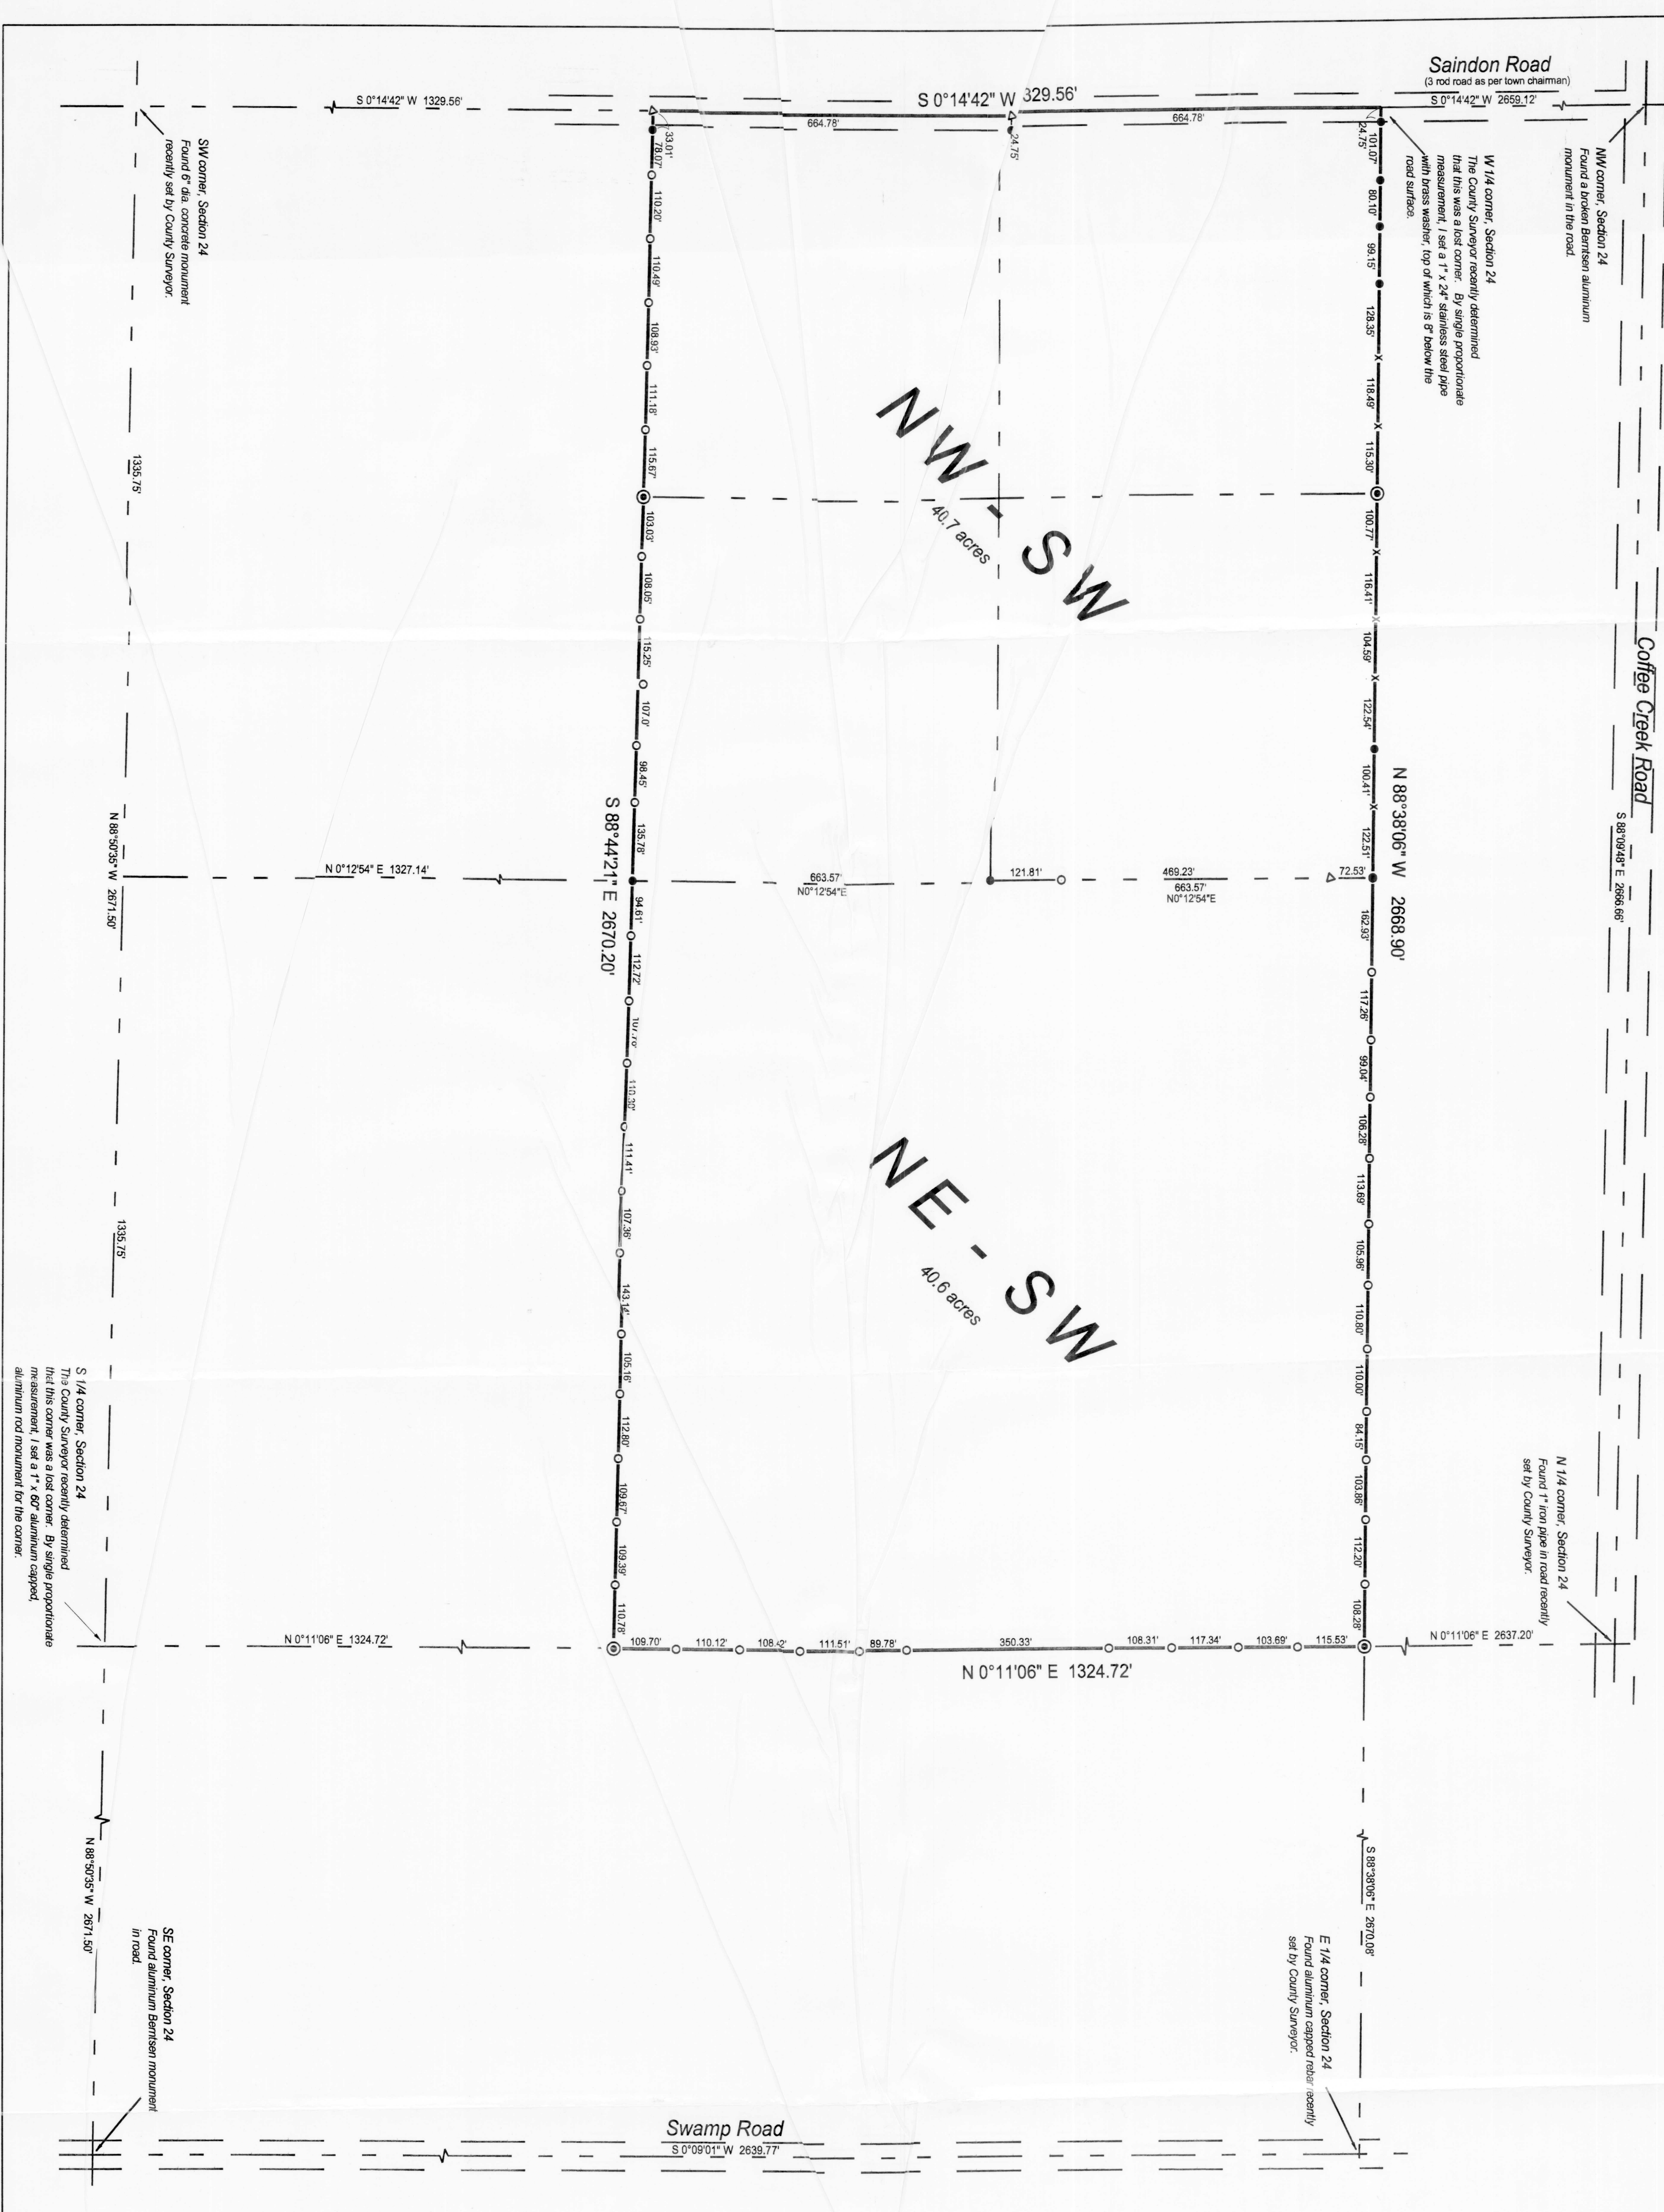
L391A

NW corner, Section 24
Found a broken Bernissen aluminum monument in the road.

W 1/4 corner, Section 24
The County Surveyor recently determined that this was a lost corner. By single proportionate measurement, I set a 1" x 24" stainless steel pipe with brass washer, top of which is 6" below the road surface.

N 1/4 corner, Section 24
Found 1" iron pipe in road recently set by County Surveyor.

E 1/4 corner, Section 24
Found aluminum capped rebar recently set by County Surveyor.

SW corner, Section 24
Found 6" dia. concrete monument recently set by County Surveyor.

S 1/4 corner, Section 24
The County Surveyor recently determined that this corner was a lost corner. By single proportionate measurement, I set a 1" x 60" aluminum capped aluminum rod monument for the corner.

SE corner, Section 24
Found aluminum Bernissen monument in road.

Bearings are from RTK-GPS work and are Lincoln County Coordinate System grid bearings.
