I, David E. Tlusty, Registered Land Surveyor, do hereby certify that, by the direction of David Seidler, owner, I have made a survey of the North Half of the Southwest Quarter of Section 24, Township 34 North, Range 5 East, Lincoln County, Wisconsin, as shown hereon. I further certify that this map is a true and correct representation of said survey and that this survey is correct to the best of my knowledge and belief.

Survey for David Seidler, owner  
 The North Half of the Southwest Quarter of Section 24, T. 34 N., R. 5 E., Lincoln County, WI

SCALE: 1" = 150'	DATE: April 2005 Revised 4/2012	DRAWN BY: dt	MAP #:
---------------------	---------------------------------------	-----------------	--------

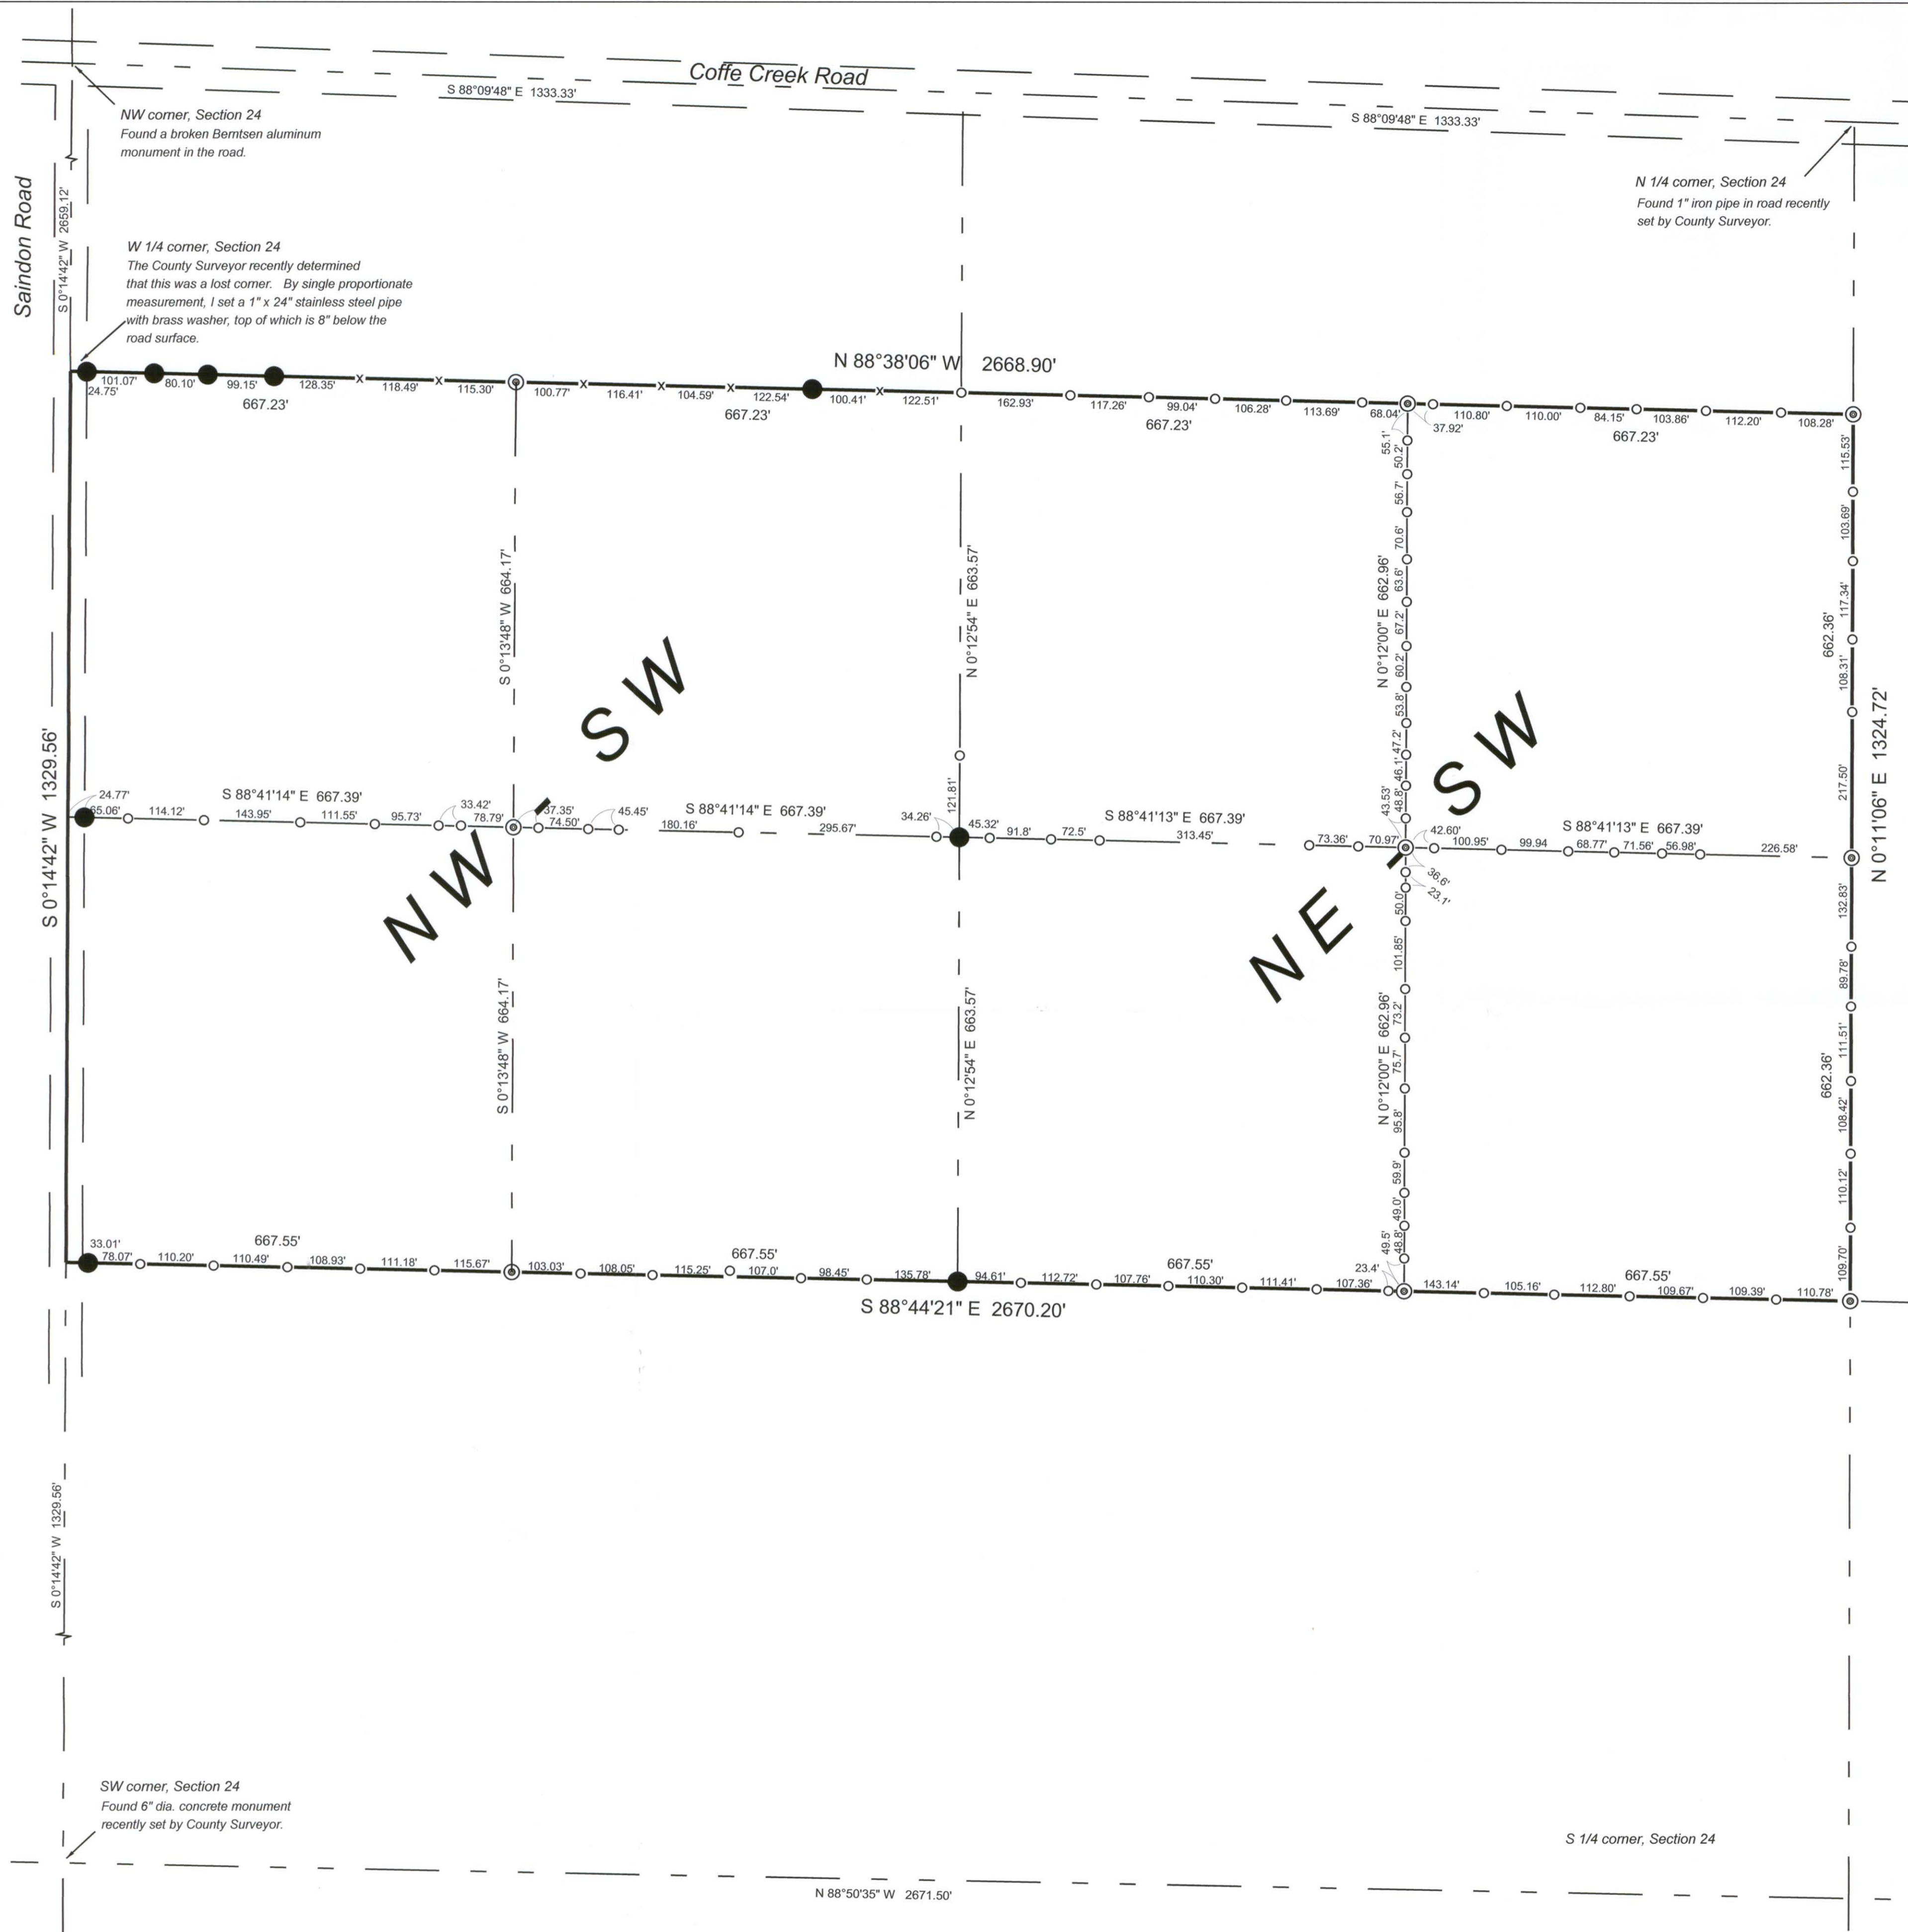
2491A

- iron rod set  
These iron rods are between 3/4" and 1" dia. and range from 24" to 32" long, have barbed points welded on near the bottom and are topped with a stainless steel plate ranging in size from about 2.5" square to about 6" square.
  - 3/8" - 1/2" x 48" iron rod set  
The landowner may be replacing this rods with more substantial monuments in the near future.
  - x steel fence post set
  - ⊙ stainless steel pipe set  
These pipe are 3/4" to 1 1/4" inside diameter and 20" - 36" long. The have barbed points welded near bottom and are topped with a stainless steel plate ranging in size from about 2.5" square to about 6" square or 5" to 12" diameter.
- Bearings shown are Lincoln County Coordinate System Grid bearings

Revised April 10, 2012 to show additional markers set

E 1/4 corner, Section 24  
 Found aluminum capped rebar recently set by County Surveyor.

SE corner, Section 24  
 Found aluminum Bentsen monument in road.
