This survey was done by order of Bob Steigerwaldt.

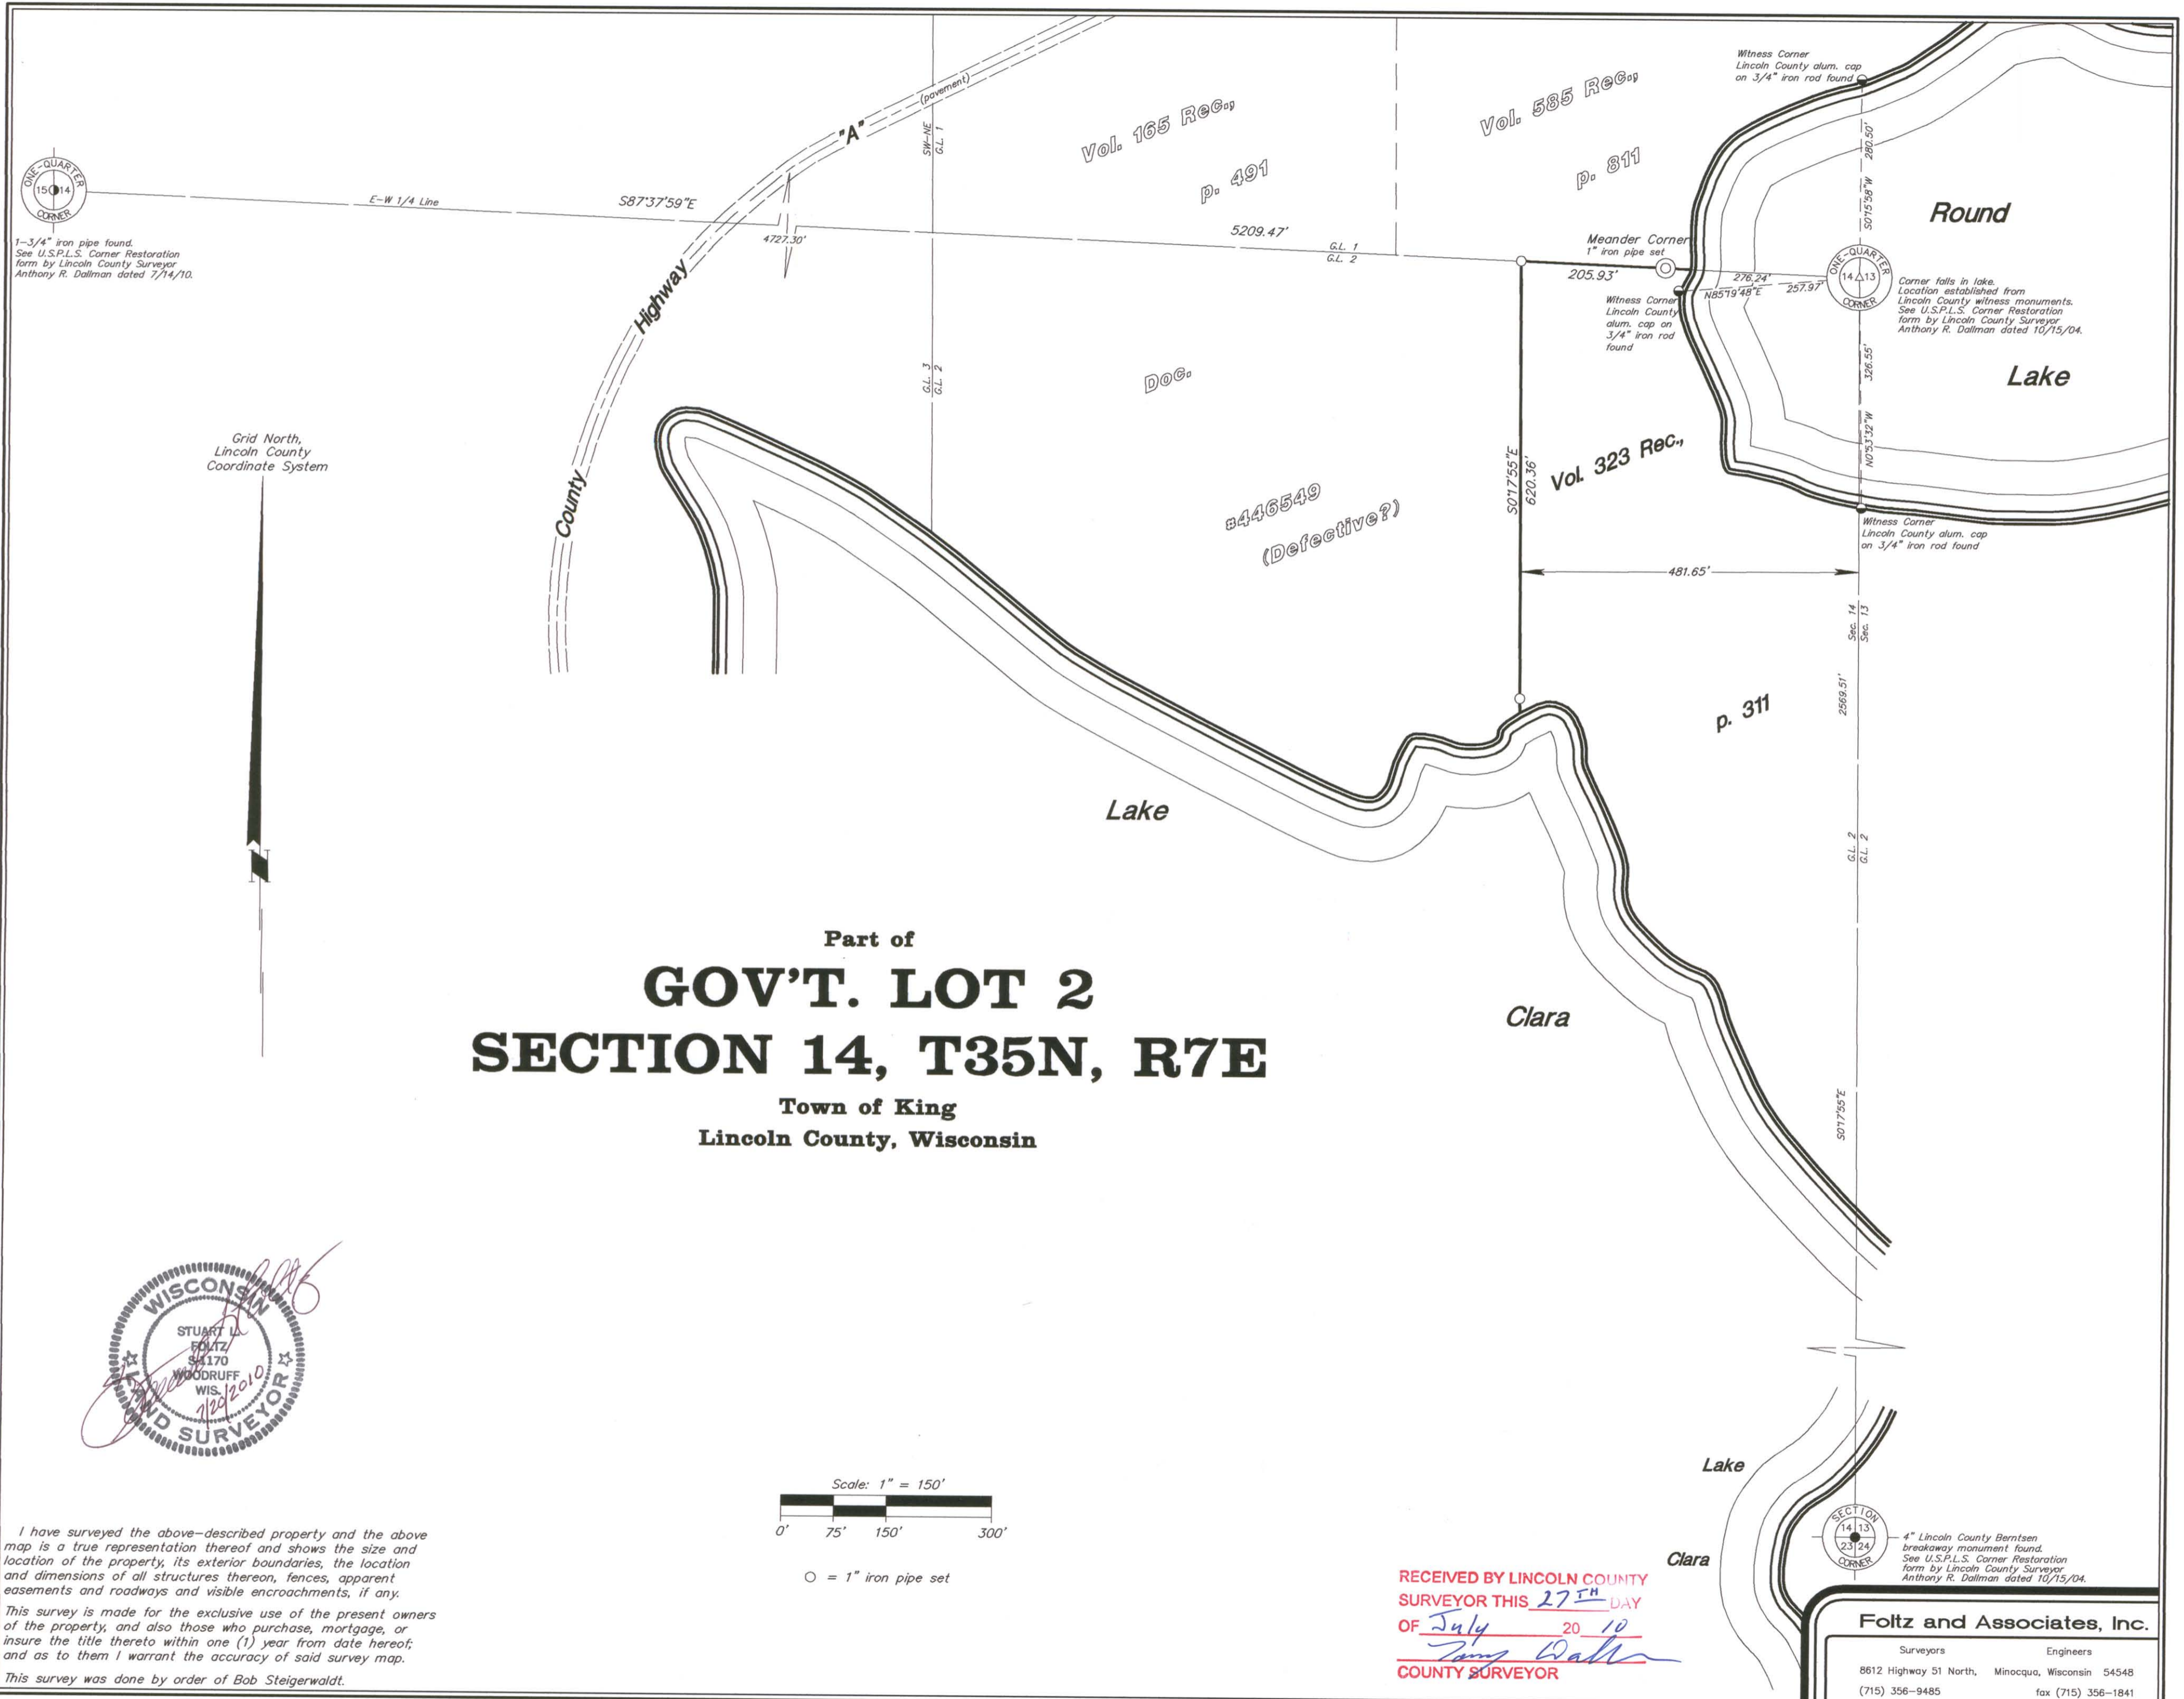
1-3/4" iron pipe found.  
 See U.S.P.L.S. Corner Restoration  
 form by Lincoln County Surveyor  
 Anthony R. Dalman dated 7/14/10.

Grid North,  
 Lincoln County  
 Coordinate System

4" Lincoln County Bernsten  
 breakaway monument found.  
 See U.S.P.L.S. Corner Restoration  
 form by Lincoln County Surveyor  
 Anthony R. Dalman dated 10/15/04.
