CERTIFIED LAND CORNER RESTORATION

Index No. U-/

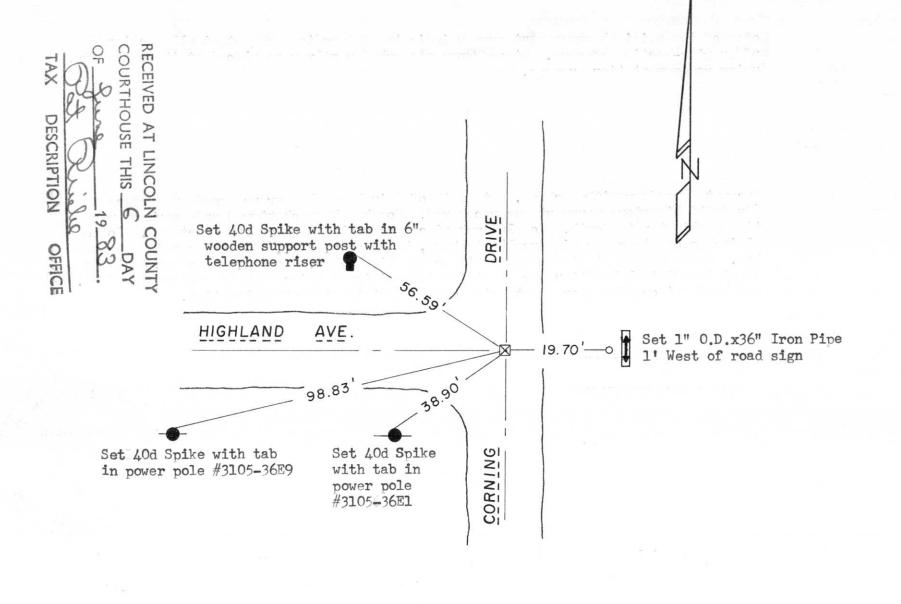
See sketch on reverse

O = Corner monument restored.

Excavated roadway with backhoe. At depth of 6 inches below gravel roadway surface a 6"x8"x33" Limestone monument was recovered. Top had been shattered and monument was tipped slightly to South. Top 10 inch piece was still in place but fractured. Bottom 23 inches of stone were in excellent shape, hence a new chisel "X" was cut into center top. Monument was straightened and temporary ties taken. Bottom 23 inch segment was reset in original location such that top is positioned 5 inches below roadway surface. Set 1"x36" iron pipe along North side of monument to aid future location.
