CERTIFIED LAND CORNER RESTORATION

Index No. Q - 23

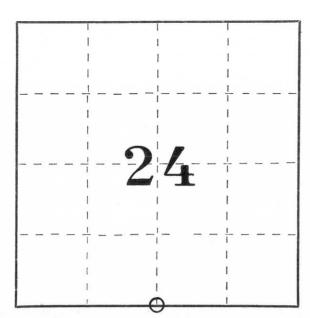
O = Corner monument restored.

We found a $6" \times 6"$ granite monument 18" below the surface of the road approximately 1" south of the actual granite roadway.
