# U S PUBLIC LAND SURVEY MONUMENT RECORD

A-E 7.08(3)(a) Identity of corner:  
 MEANDER CORNER, EAST-WEST 1/4 LINE,  
 SECTION 15, EAST OF THE RIVER  
 TOWNSHIP 35 NORTH,  
 RANGE 07 EAST OF THE 4TH PM,  
 TOWN OF KING, COUNTY OF LINCOLN

### 2022-Lincoln County PLSS Corner Remonumentation and GPS Services

Wisconsin Corner Point Identification Number: 43507152039

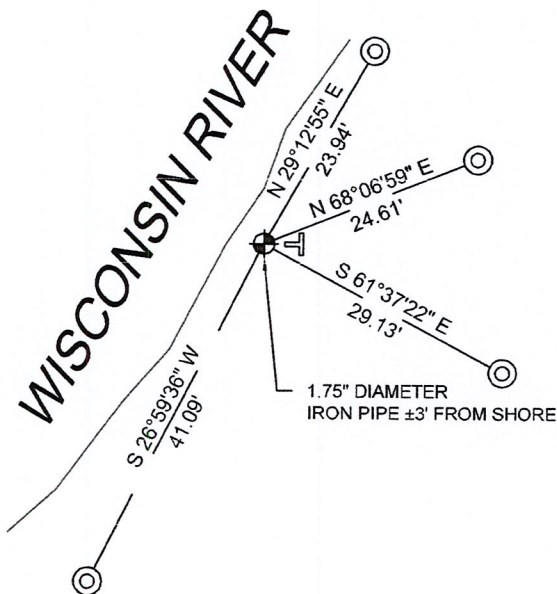
A-E 7.08(3)(c)(d) Plan view of corner with references to at least 4 witness monuments.

September 15, 2022 - While performing the 2022 Lincoln County PLSS Corner Remonumentation and GPS Services project, I found a 1.75" iron pipe near the computed position provided by Lincoln County. I established 4 new reference monuments as shown below.

BEARINGS LISTED TO THE NEAREST SECOND ARE REFERENCED TO WISCONSIN COUNTY COORDINATE REFERENCE SYSTEM - LINCOLN COUNTY ZONE. ALL OTHER BEARINGS ARE MAGNETIC

- 1.75" diameter iron Pipe, found
- 7/8" diameter X 30" long - iron rod with 2" diameter aluminum cap, set
- Vinyl T-post, set ±1 foot east of corner
