U.S. PUBLIC LAND SURVEY MONUMENT RECORD

(a) Corner location: Township 31 North

Range 6 East

Section 9

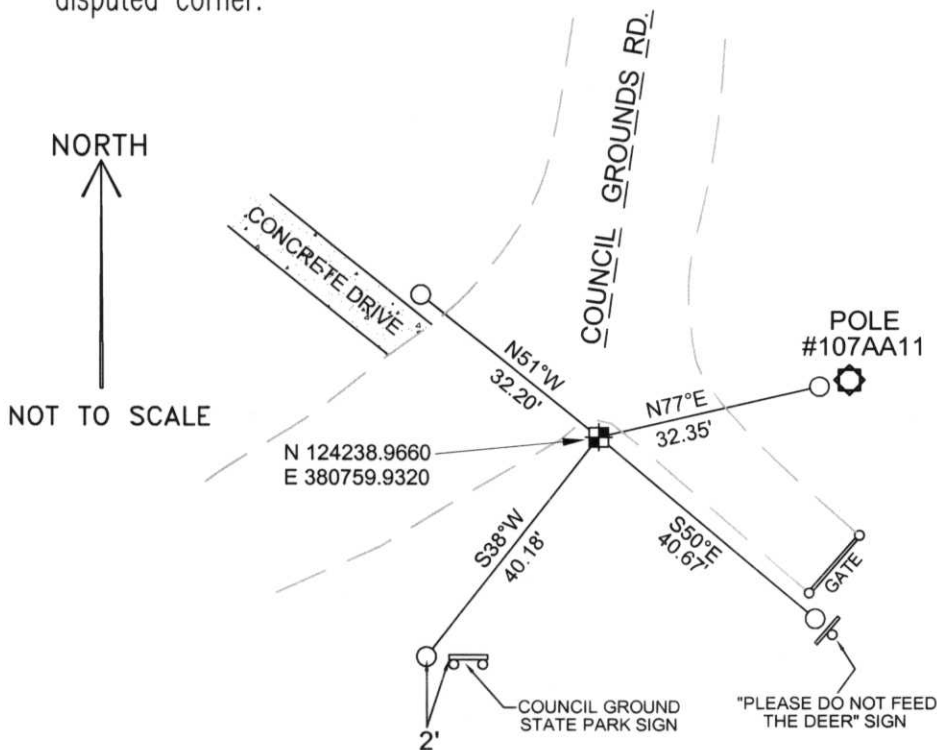
FOUND 5" x 5" CONCRETE MONUMENT WITH BRASS CAP SET BY HARRY HALL IN 1939. WE ACCEPTED THIS LOCATION AS THE BEST EVIDENCE OF THE CORNER LOCATION. TIED OUT MONUMENT TO PERPETUATE CORNER LOCATION.

(c)(d)(e) Plan view of corner with ties to at least 4 witness monuments. If in disagreement with previously established corner, show the distances between the two corners and also indicate the ties to the disputed corner.

COORDINATES ARE REFERENCED TO THE LINCOLN COUNTY COORDINATE SYSTEM AS DEVELOPED BY THE WISCONSIN DEPARTMENT OF TRANSPORTATION AND WERE DETERMINED BY GPS OBSERVATIONS ON CONTROL POINTS AS SUPPLIED BY LINCOLN COUNTY.

BEARINGS ARE REFERENCED TO MAGNETIC NORTH.

- EXISTING POWER POLE
- SET 3/4" x 30" REBAR W/ ALUM CAP
- EAST 1/4 CORNER FOUND CONCRETE MONUMENT WITH BRASS CAP
