## LINCOLN COUNTY U.S. PUBLIC LAND SURVEY MONUMENT LOCATION RECORD SECTION \_\_\_\_\_ 32 N TOWNSHIP \_\_\_ RANGE \_\_\_\_ FOUND | LANDMARK BENCHMARK \_\_\_\_ SET 🔲 SCHLEY RESET 🛛 CITY, VILLAGE, TOWN 1" REBAR CORNER IDENTITY: RE-TIED 🛛 SECTION LINCOLN COUNTY COORDINATE: N: 147958.315 E: 423205.371 ELEVATION-(FEET): \_\_\_\_\_ DATUM: NAD83 (2011) 23 PARTLY CLOUDY WEATHER: \_\_\_\_\_ DATE OF SURVEY:\_\_\_\_ 5-3-2018 TEMPERATURE: 55 • F KEITH WALKOWSKI / AUSTIN PELOT SURVEY PARTY:\_\_\_ BASIS FOR MONUMENT LOCATION: LOCATION (Indicated By X) (DESCRIBE METHOD OF SURVEY AND CORNER AUTHENTICATION) SEARCHED FOR THE NORTHEAST CORNER AND FOUND A BROKEN LEANING BERNTSEN ALUMINUM MONUMENT AND THREE OVRGROWN TIES FROM THE 1979 TIESHEET BY SHERIDAN SCHWARK, DUG FURTHUR DOWN AND FOUND THE ENTIRE DISTURBED BERNTSEN MONUMENT. SET A 1" REBAR USING THE THREE REMAINING TIES TO RESET THE CORNER AND SET FOUR S-2717 NEW TIES TO PERPETUATE THE CORNER LOCATION AS SHOWN BELOW. MOSINEE, CERTIFIED CORREC FIELD BOOK NO. NA PAGE NO. NA KEITH J. WALKOWSKI S-2717 COMPANY RIVERSIDE LAND SURVEYING LLC Professional Land Surveyor TIE SKETCH: **ECKS LANE** - SET 1" REBAR SET 1" REBAR WITH ALUMINUM CAP S82° 13' 45"E 39.

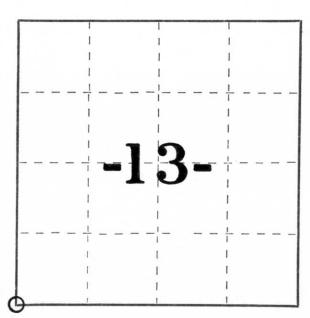
O = Corner monument restored.

A 1937 S.T.H. "17" highway plan shows a stone monument 320' South of the centerline of S.T.H. "17". We measured the 320' from the existing centerline of S.T.H. "17" and excavated Leck's Lane with a backhoe. We found a 7" x 7" x 32" red granite monument lying on its side. A obvious hole filled with rotten granite with original soil around was along side the stone. This appeared to be the original hole that the stone was in before it was knocked out. We set a Lincoln County Berntsen Monument at that location.

Description of monument and accessories I established to perpetuate the original location of this corner.
