LINCOLN COUNTY U.S. PUBLIC LAND TIE SHEET RECORD

SECTION 18
TOWNSHIP 33N
RANGE 4 E

CORNER INDENTITY: 2.0" IRON PIPE W/CAP

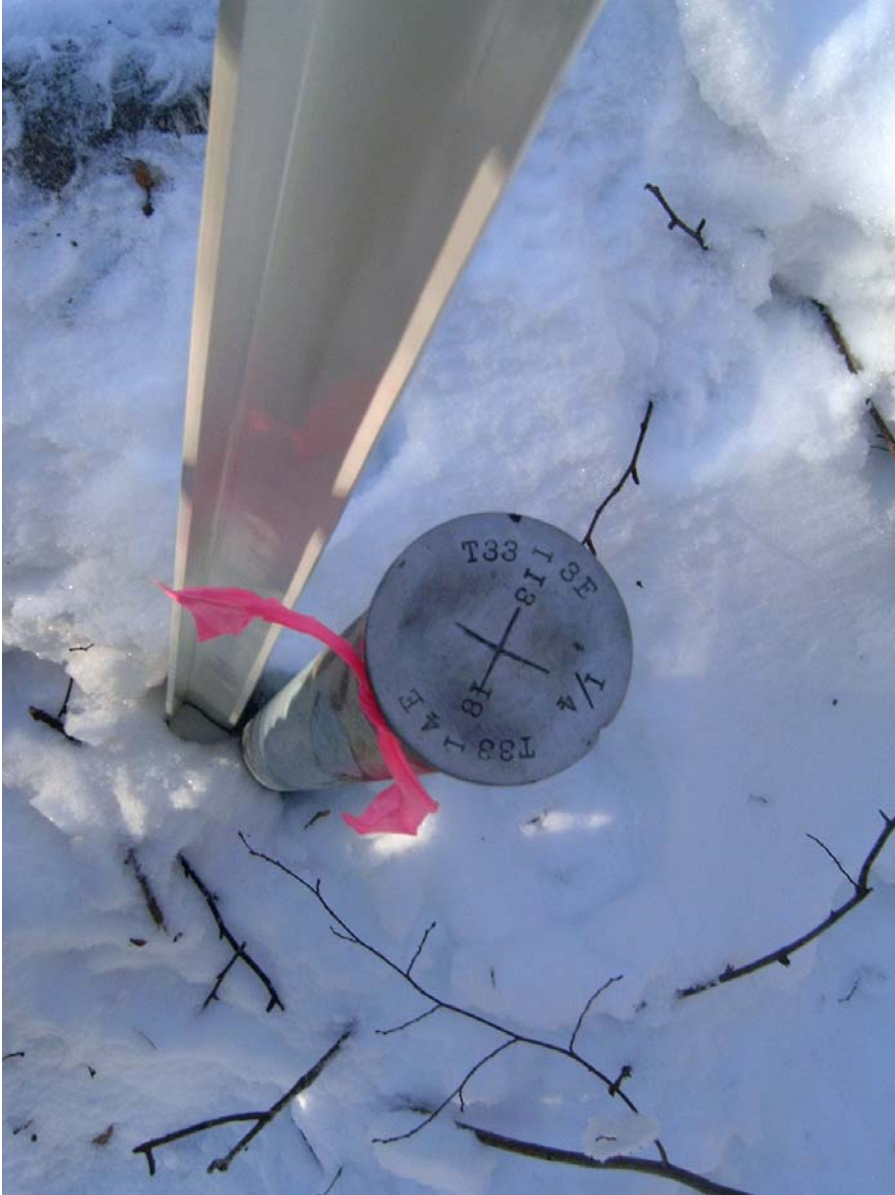
Picture 5 –Found 2.0 Iron Pipe with Stamped Cap at Corner

(DESCRIBE METHOD OF SURVEY AND CORNER AUTHENTICATION)
Found 2" iron pipe with cap at corner. Blue line, Property evidence, conversation with Taylor County Surveyor, comparison to A.W. Kordick's notes, comparison to the Wisconsin Conservation Commission's Notes, and comparison to the original notes supports the 2" iron pipe as corner.
