LINCOLN COUNTY U.S. PUBLIC LAND TIE SHEET RECORD

SECTION 31
TOWNSHIP 33N
RANGE 4 E

313341

CORNER INDENTITY: 2.0" IRON PIPE W/CAP

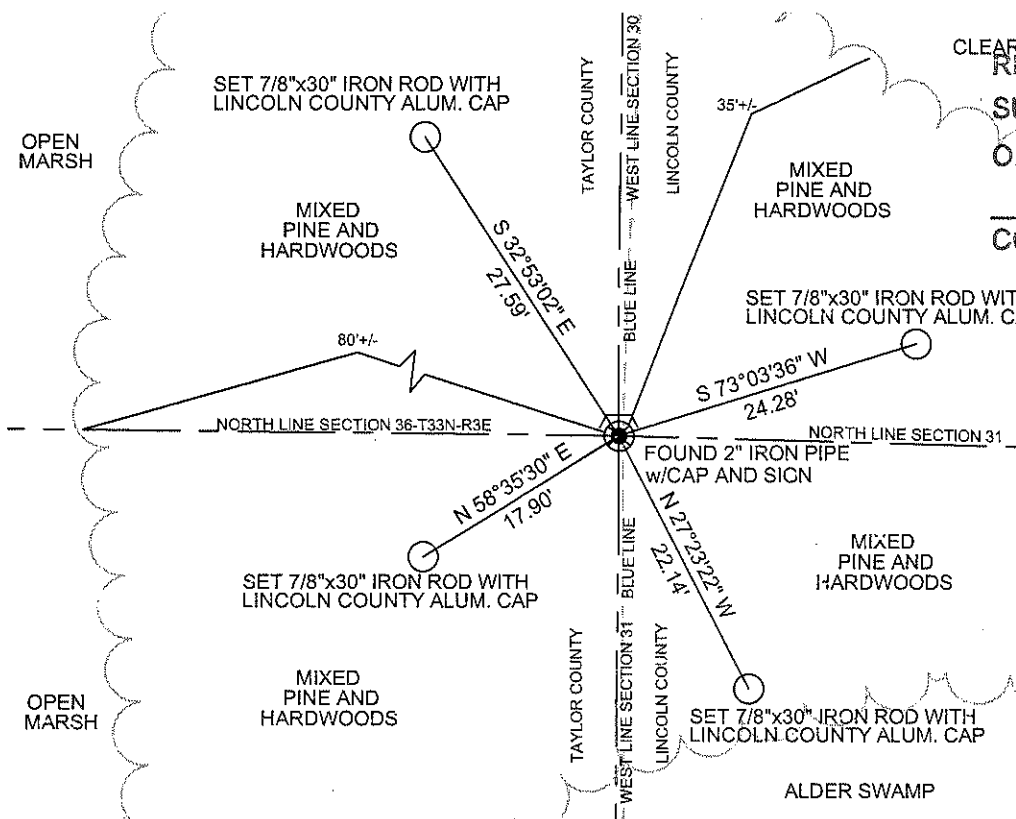
TIE SKETCH:

SHOW MINIMUM OF FOUR (4) HORIZONTAL TIE DISTANCES TO FIXED WITNESS MONUMENTS.
DESCRIBE ALL MONUMENTS FOUND OR SET. ALL DISTANCES SHOWN IN US SURVEY FEET.

NOT TO SCALE
BEARINGS REFERENCED TO LINCOLN COUNTY COORDINATE SYSTEM

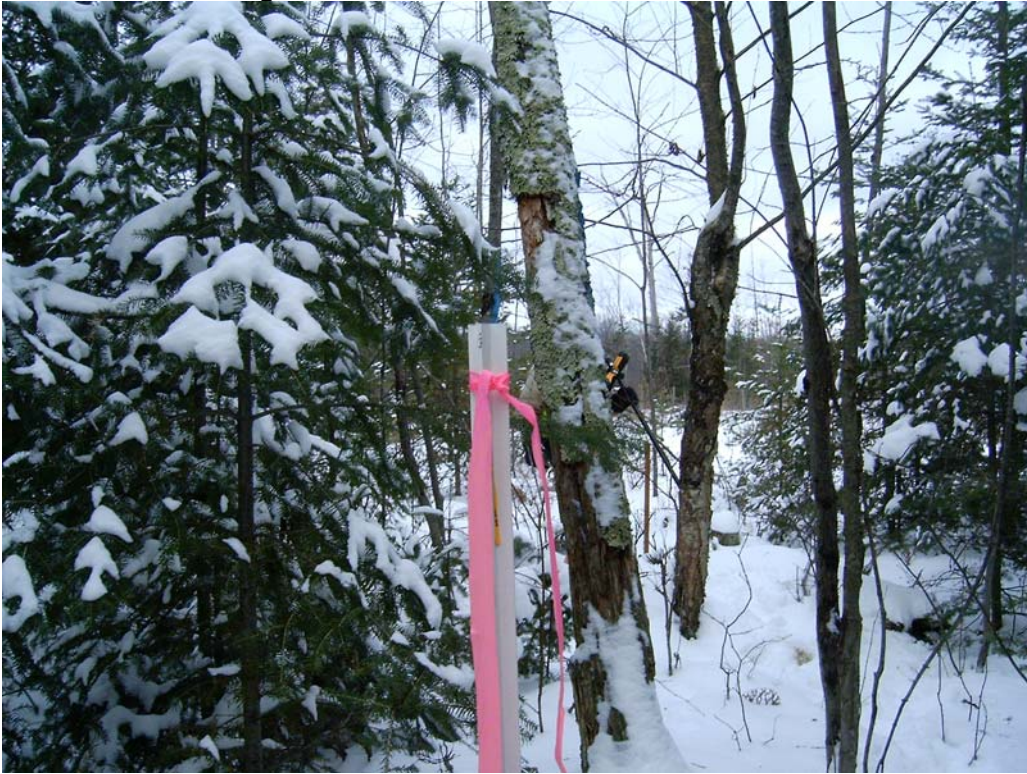
Picture 1 – Looking North From Corner at Blue Line

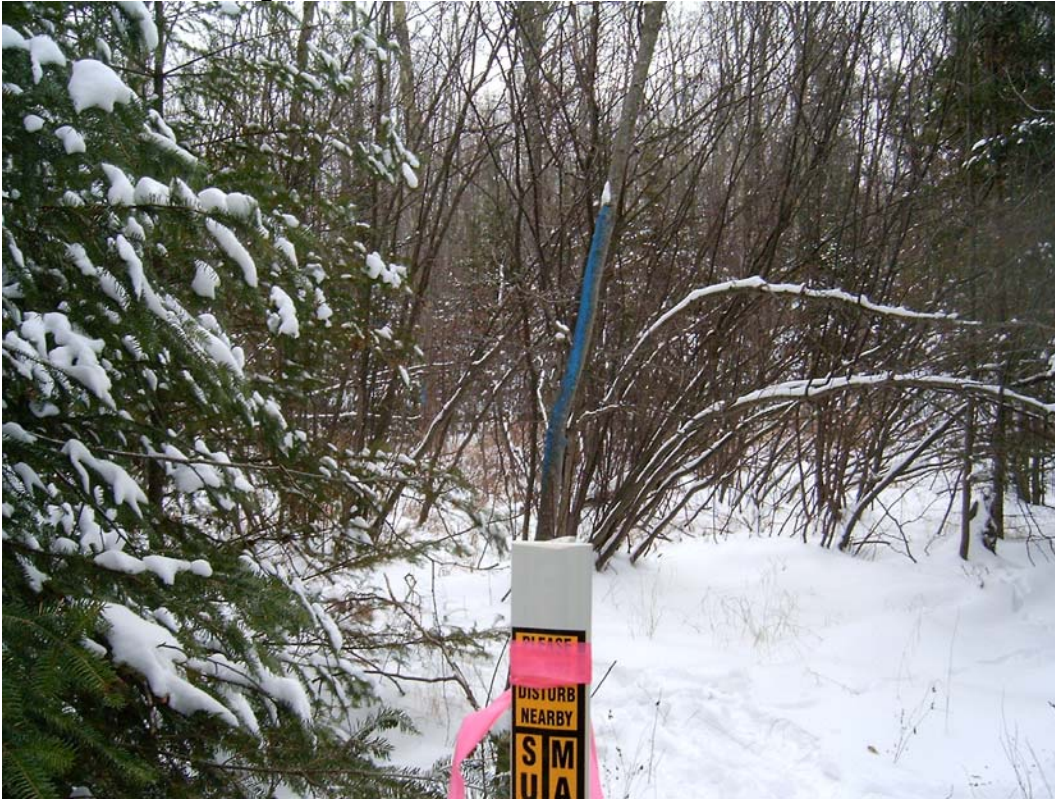
Picture 3 – Looking South From Corner at Blue Line

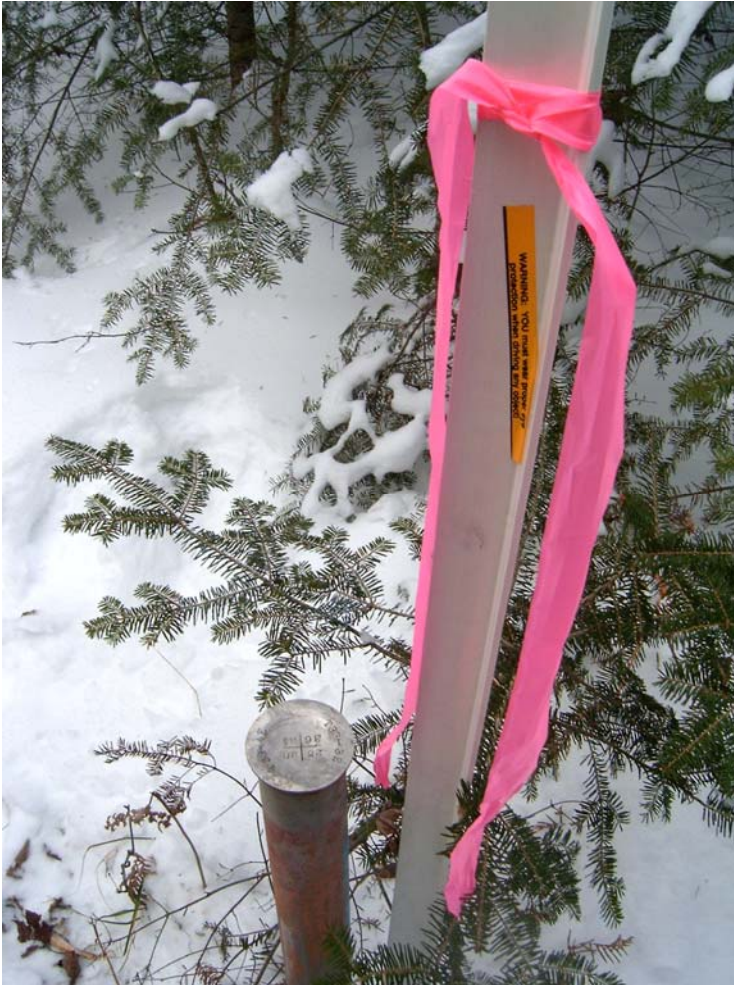
Found 2" iron pipe with cap at corner. Blue line, Property evidence, conversation with Taylor County Surveyor, and comparison to the original notes supports the 2" iron pipe as corner.

Picture 5 –Found 2.0 Iron Pipe with Stamped Cap at corner
