LINCOLN COUNTY U.S. PUBLIC LAND TIE SHEET RECORD

SECTION 31
TOWNSHIP 33N
RANGE 4 E

313344

CORNER IDENTIVITY: 2.0" IRON PIPE W/CAP

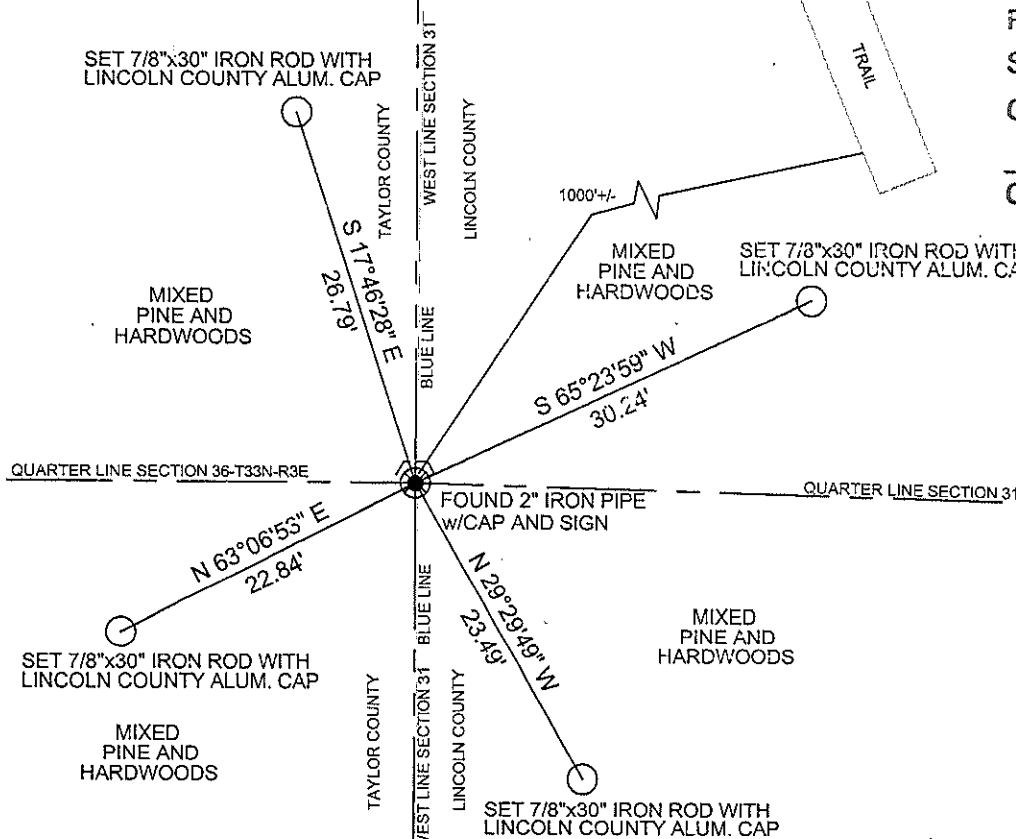
TIE SKETCH:

SHOW MINIMUM OF FOUR (4) HORIZONTAL TIE DISTANCES TO FIXED WITNESS MONUMENTS.
DESCRIBE ALL MONUMENTS FOUND OR SET. ALL DISTANCES SHOWN IN US SURVEY FEET.

NOT TO SCALE
BEARINGS REFERENCED TO LINCOLN COUNTY COORDINATE SYSTEM

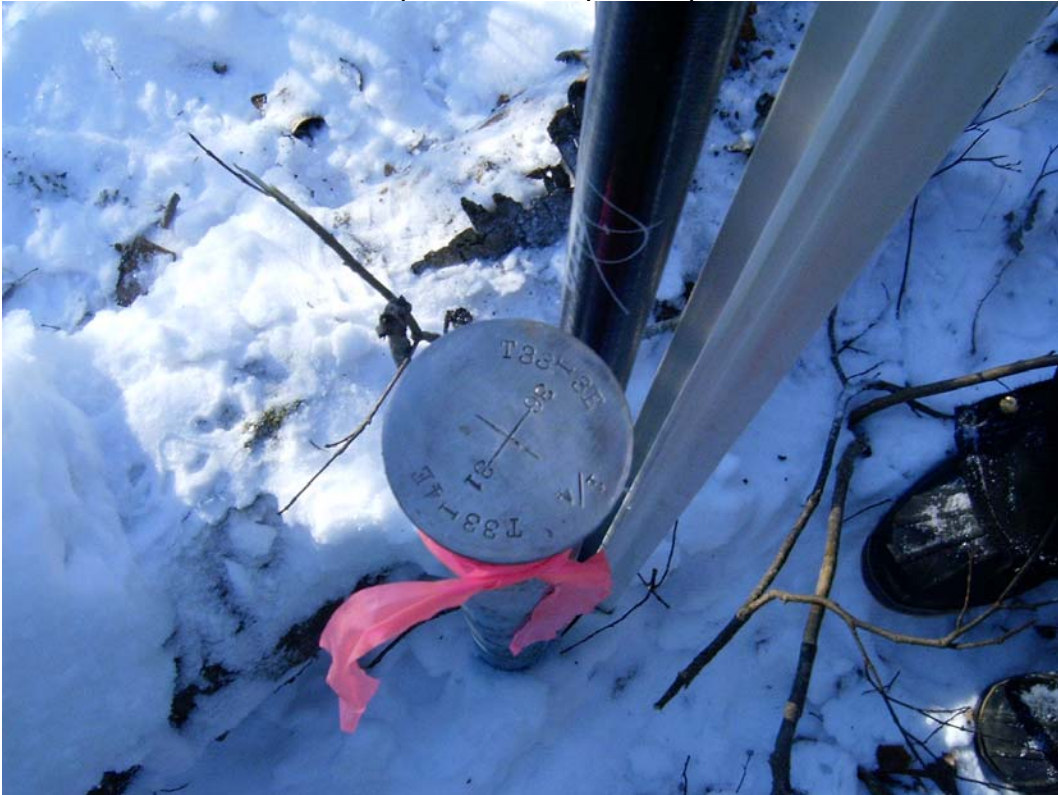
Found 2" iron pipe with cap at corner. Blue line, Property evidence, conversation with Taylor County Surveyor, and comparison to the original notes supports the 2" iron pipe as corner.

Picture 5 –Found 2.0 Iron Pipe with Stamped Cap at corner
