LINCOLN COUNTY U.S. PUBLIC LAND TIE SHEET RECORD

SECTION 7
TOWNSHIP 33N
RANGE 4 E

LANDMARK

CORNING
CITY, VILLAGE, TOWN

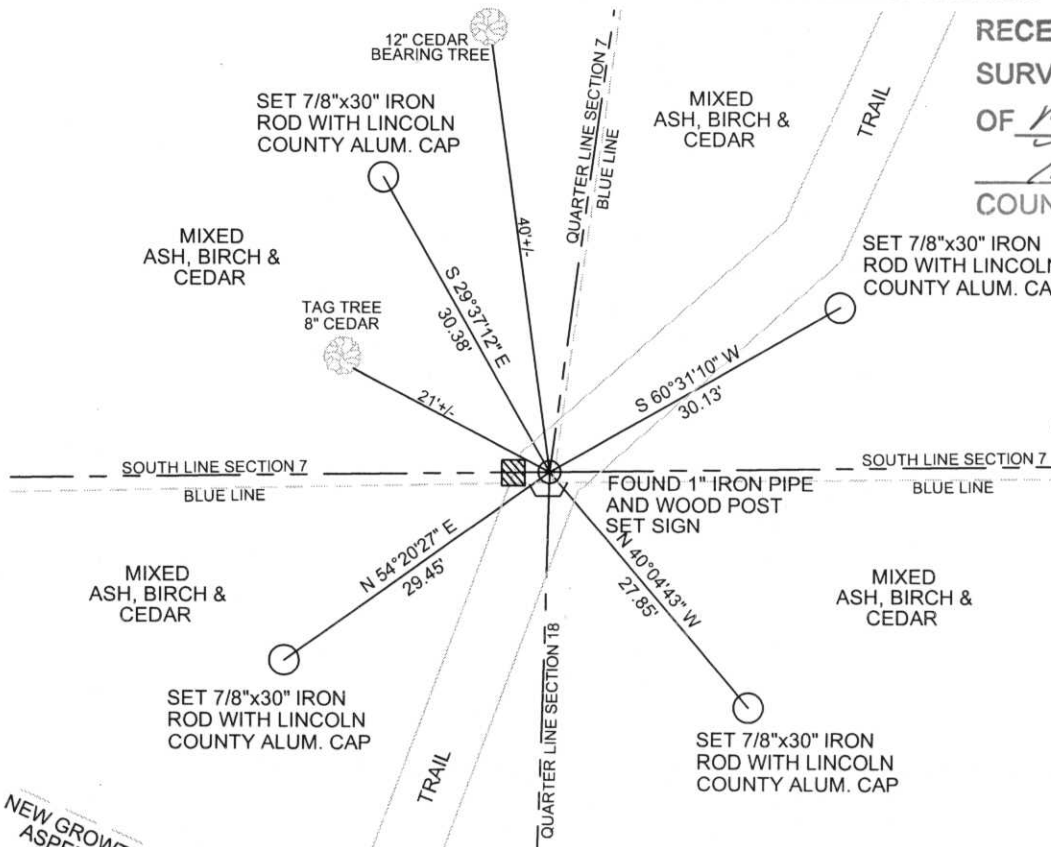
TIE SKETCH:

SHOW MINIMUM OF FOUR (4) HORIZONTAL TIE DISTANCES TO FIXED WITNESS MONUMENTS.
DESCRIBE ALL MONUMENTS FOUND OR SET. ALL DISTANCES SHOWN IN US SURVEY FEET.

NOT TO SCALE
BEARINGS REFERENCED TO LINCOLN COUNTY COORDINATE SYSTEM

NEW GROWTH ASPEN

2.3

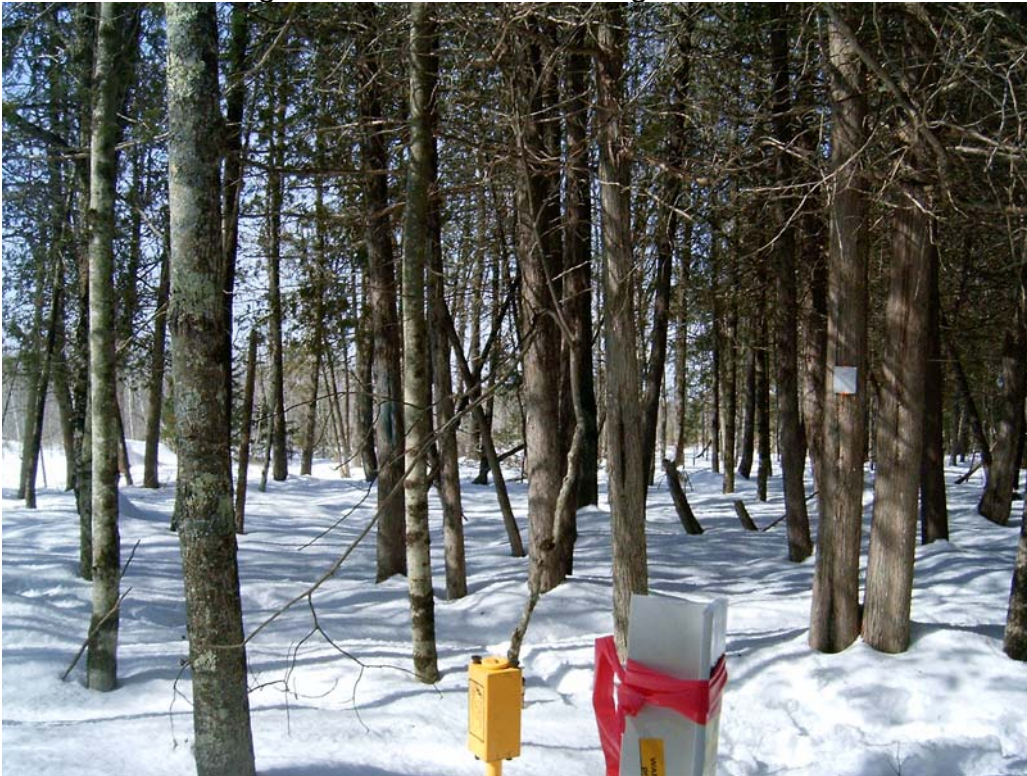
Picture 4 – Looking West From Corner at Tag Tree

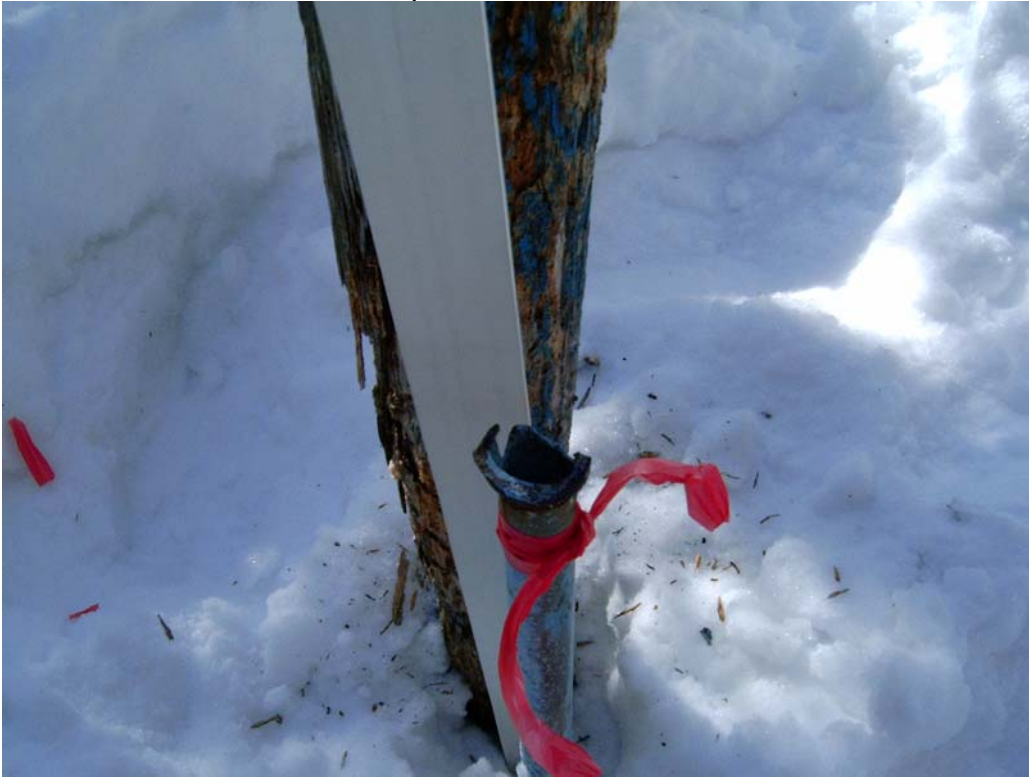
Picture 5 –Found 1.0” Iron Pipe and Post at corner

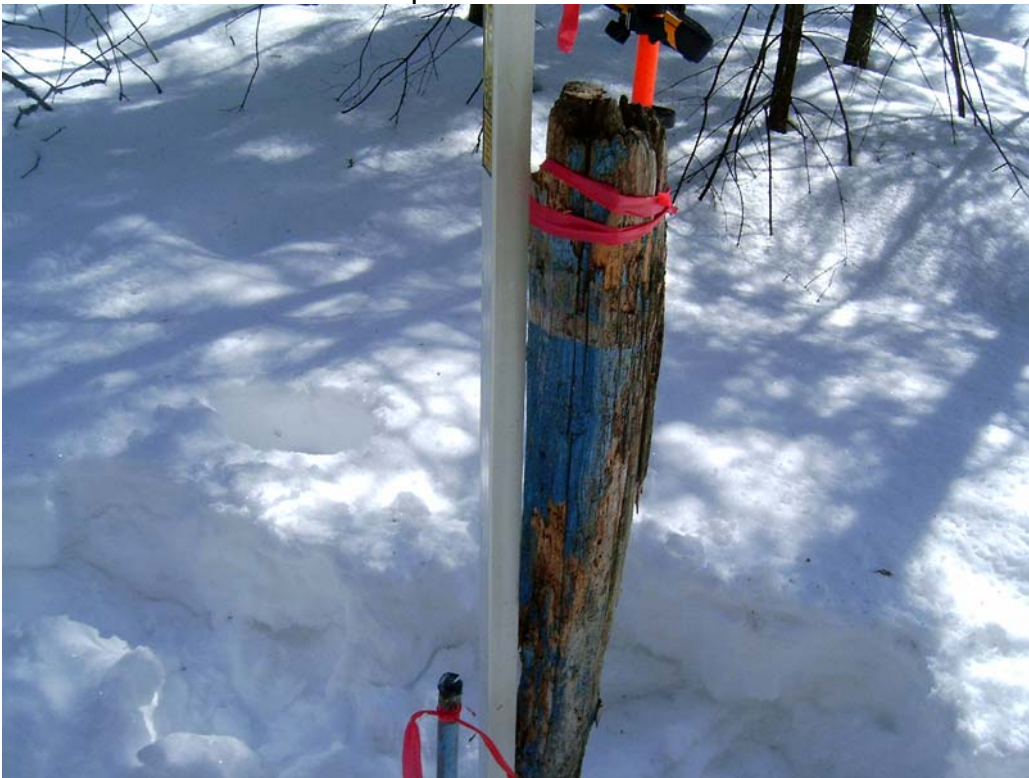
Found 1" Iron Pipe and wood post at corner. Property evidence, Blue lines, comparison to surveys done by Owens-Illinois in 1960, and comparison to the original notes supports the 1" Iron Pipe and wood post as corner.

Picture 6 –Found 1.0” Iron Pipe and Post at Corner
