# Attachment to Tie Sheet Q-23, T34N, R5E

# LINCOLN COUNTY U.S. PUBLIC LAND CORNER RESTORATION

The Quarter corner common to Sections 24 & 25, T. 34 N., R. 5 EW.

The South Quarter  
corner of Section 24,  
T. 34 N., R. 5 E.,  
Lincoln County, WI

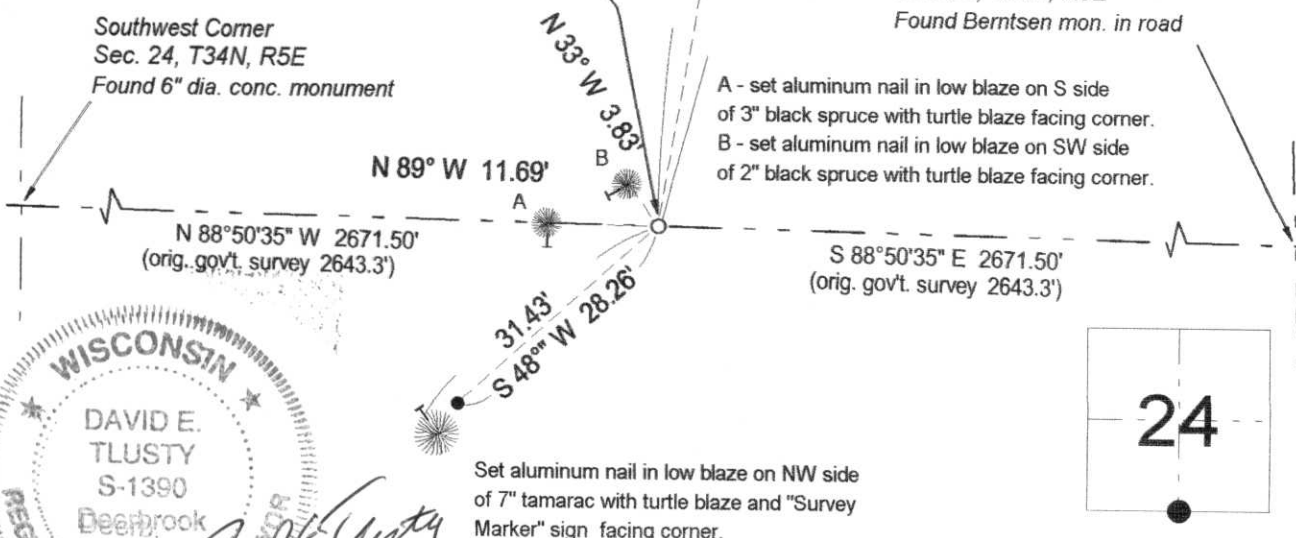
For the corner, I set a 1" x 60" aluminum pipe monument with barbed point and aluminum cap, top of which is 0.6' above the swamp. Set a white vinyl sign post on the SE edge of the monument.

Set aluminum nail in low blaze on SE side of 8" tamarac with turtle blaze facing corner.

South 1/4 Corner  
Sec. 24, T34N, R5E  
Set 1" alum. rod mon.

Southeast Corner  
Sec. 24, T34N, R5E  
Found Berntsen mon. in road

Southwest Corner  
Sec. 24, T34N, R5E  
Found 6" dia. conc. monument

A - set aluminum nail in low blaze on S side of 3" black spruce with turtle blaze facing corner.  
B - set aluminum nail in low blaze on SW side of 2" black spruce with turtle blaze facing corner.
