CERTIFIED LAND CORNER RESTORATION

Index No. M-11

S1/4 16-35-6

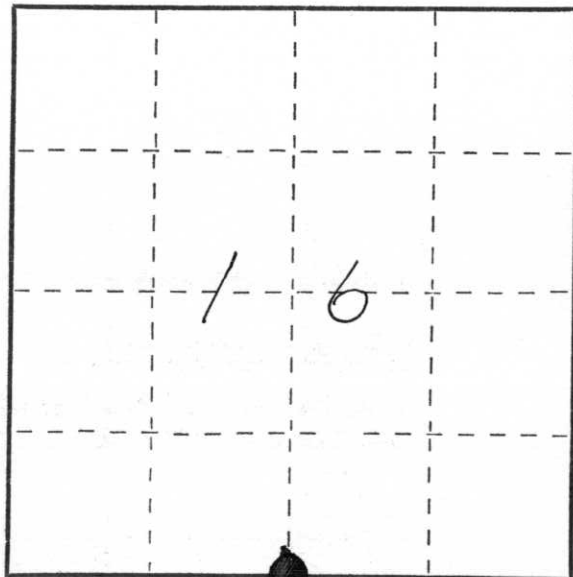
Ran a random line into the approximate location of the south quarter corner. Searched the area and found a 4" x 48" iron pipe. Along side that I found the remains of a pointed wood post. Replaced the post with a standard aluminum Berstain monument. Left the 4" pipe in place as a guard post. Cound find no record of who put the pipe there. Accepted the point as correct after running an EDM - T-2 traverse of the entire section. The distance between the southwest corner and here is approximately 40' longer than called for in the original notes.

○ = Corner monument restored.
