# LINCOLN COUNTY U.S. PUBLIC LAND TIE SHEET RECORD

SECTION 20  
TOWNSHIP 33N  
RANGE 4 E

CORNER INDENTITY: FOUND 1.5" IRON PIPE

DATE OF SURVEY: April 16, 2008  
SURVEY PARTY: Eron

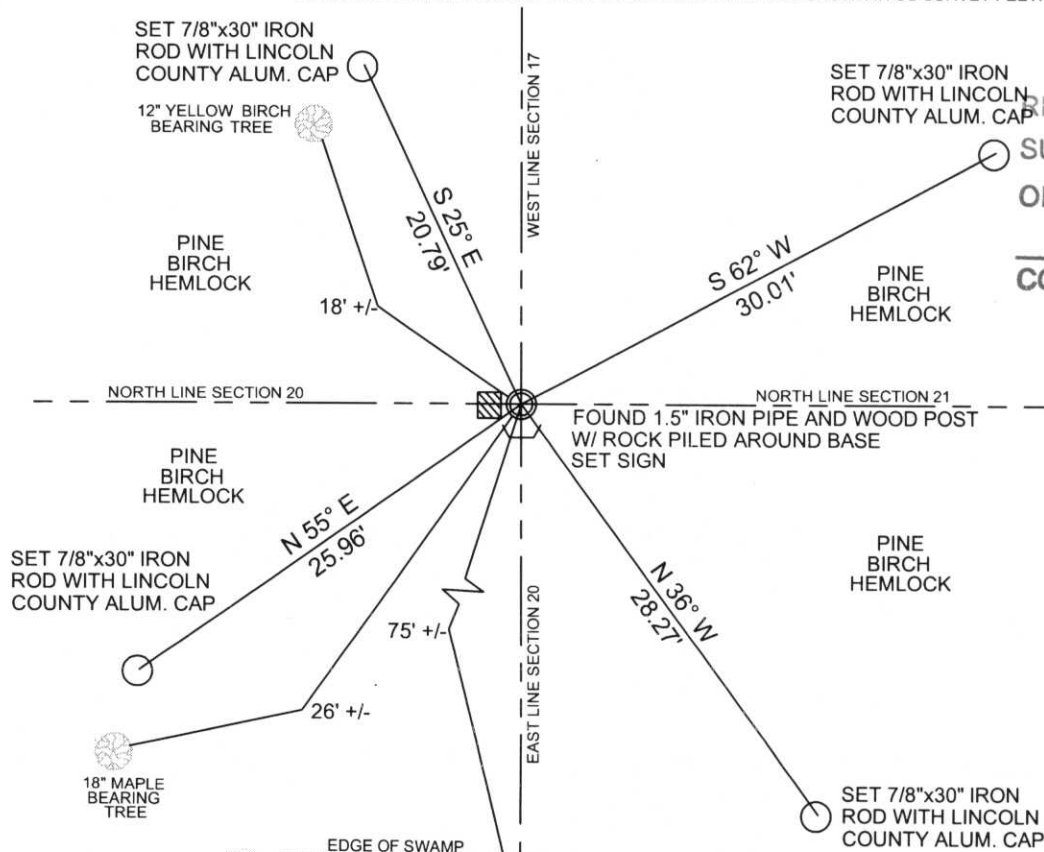
## TIE SKETCH:

SHOW MINIMUM OF FOUR (4) HORIZONTAL TIE DISTANCES TO FIXED WITNESS MONUMENTS.  
DESCRIBE ALL MONUMENTS FOUND OR SET. ALL DISTANCES SHOWN IN US SURVEY FEET.

COORDINATES ARE REFERENCED TO LINCOLN COUNTY COORDINATE SYSTEM AS DEVELOPED BY THE WI. DEPARTMENT OF TRANSPORTATION AND ARE BASED ON GPS OBSERVATIONS TO CONTROL POINTS AS SUPPLIED BY LINCOLN COUNTY.

NOT TO SCALE  
BEARINGS REFERENCED TO MAGNETIC NORTH

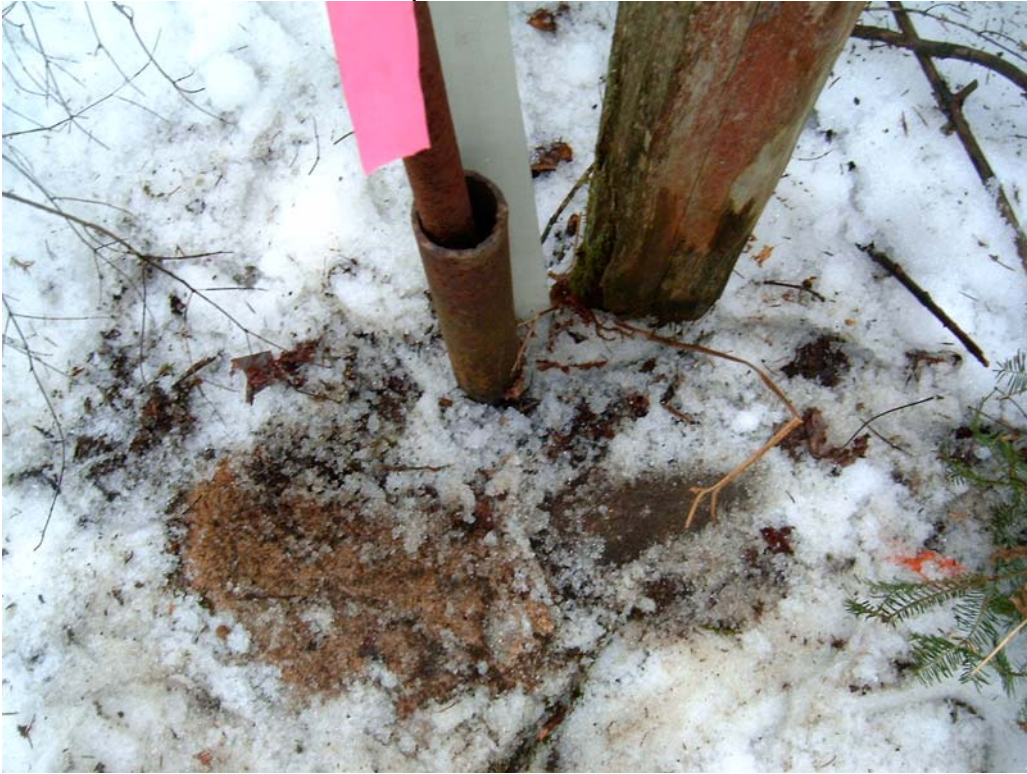
(DESCRIBE METHOD OF SURVEY AND CORNER AUTHENTICATION)  
Found 1.5" iron pipe with wood post at corner. Property evidence, comparison to the original notes and review of Owens Illinois notes dated October 17, 1957 support the 1.5" Iron Pipe and Wood Post as the Corner.

Picture 5 –Found 1.5” Iron Pipe at Corner

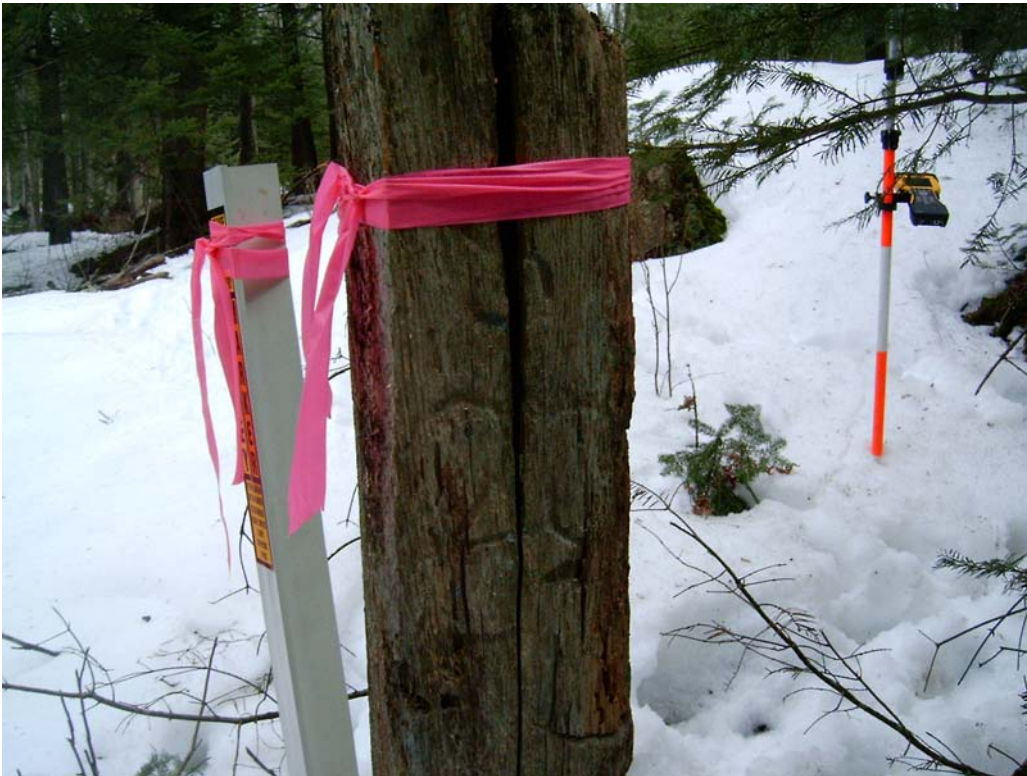
Picture 5 –Found Wood Post
